The examination and treatment of an eighteenth century picture frame, South Tipperary County Museum

Damian Lizun

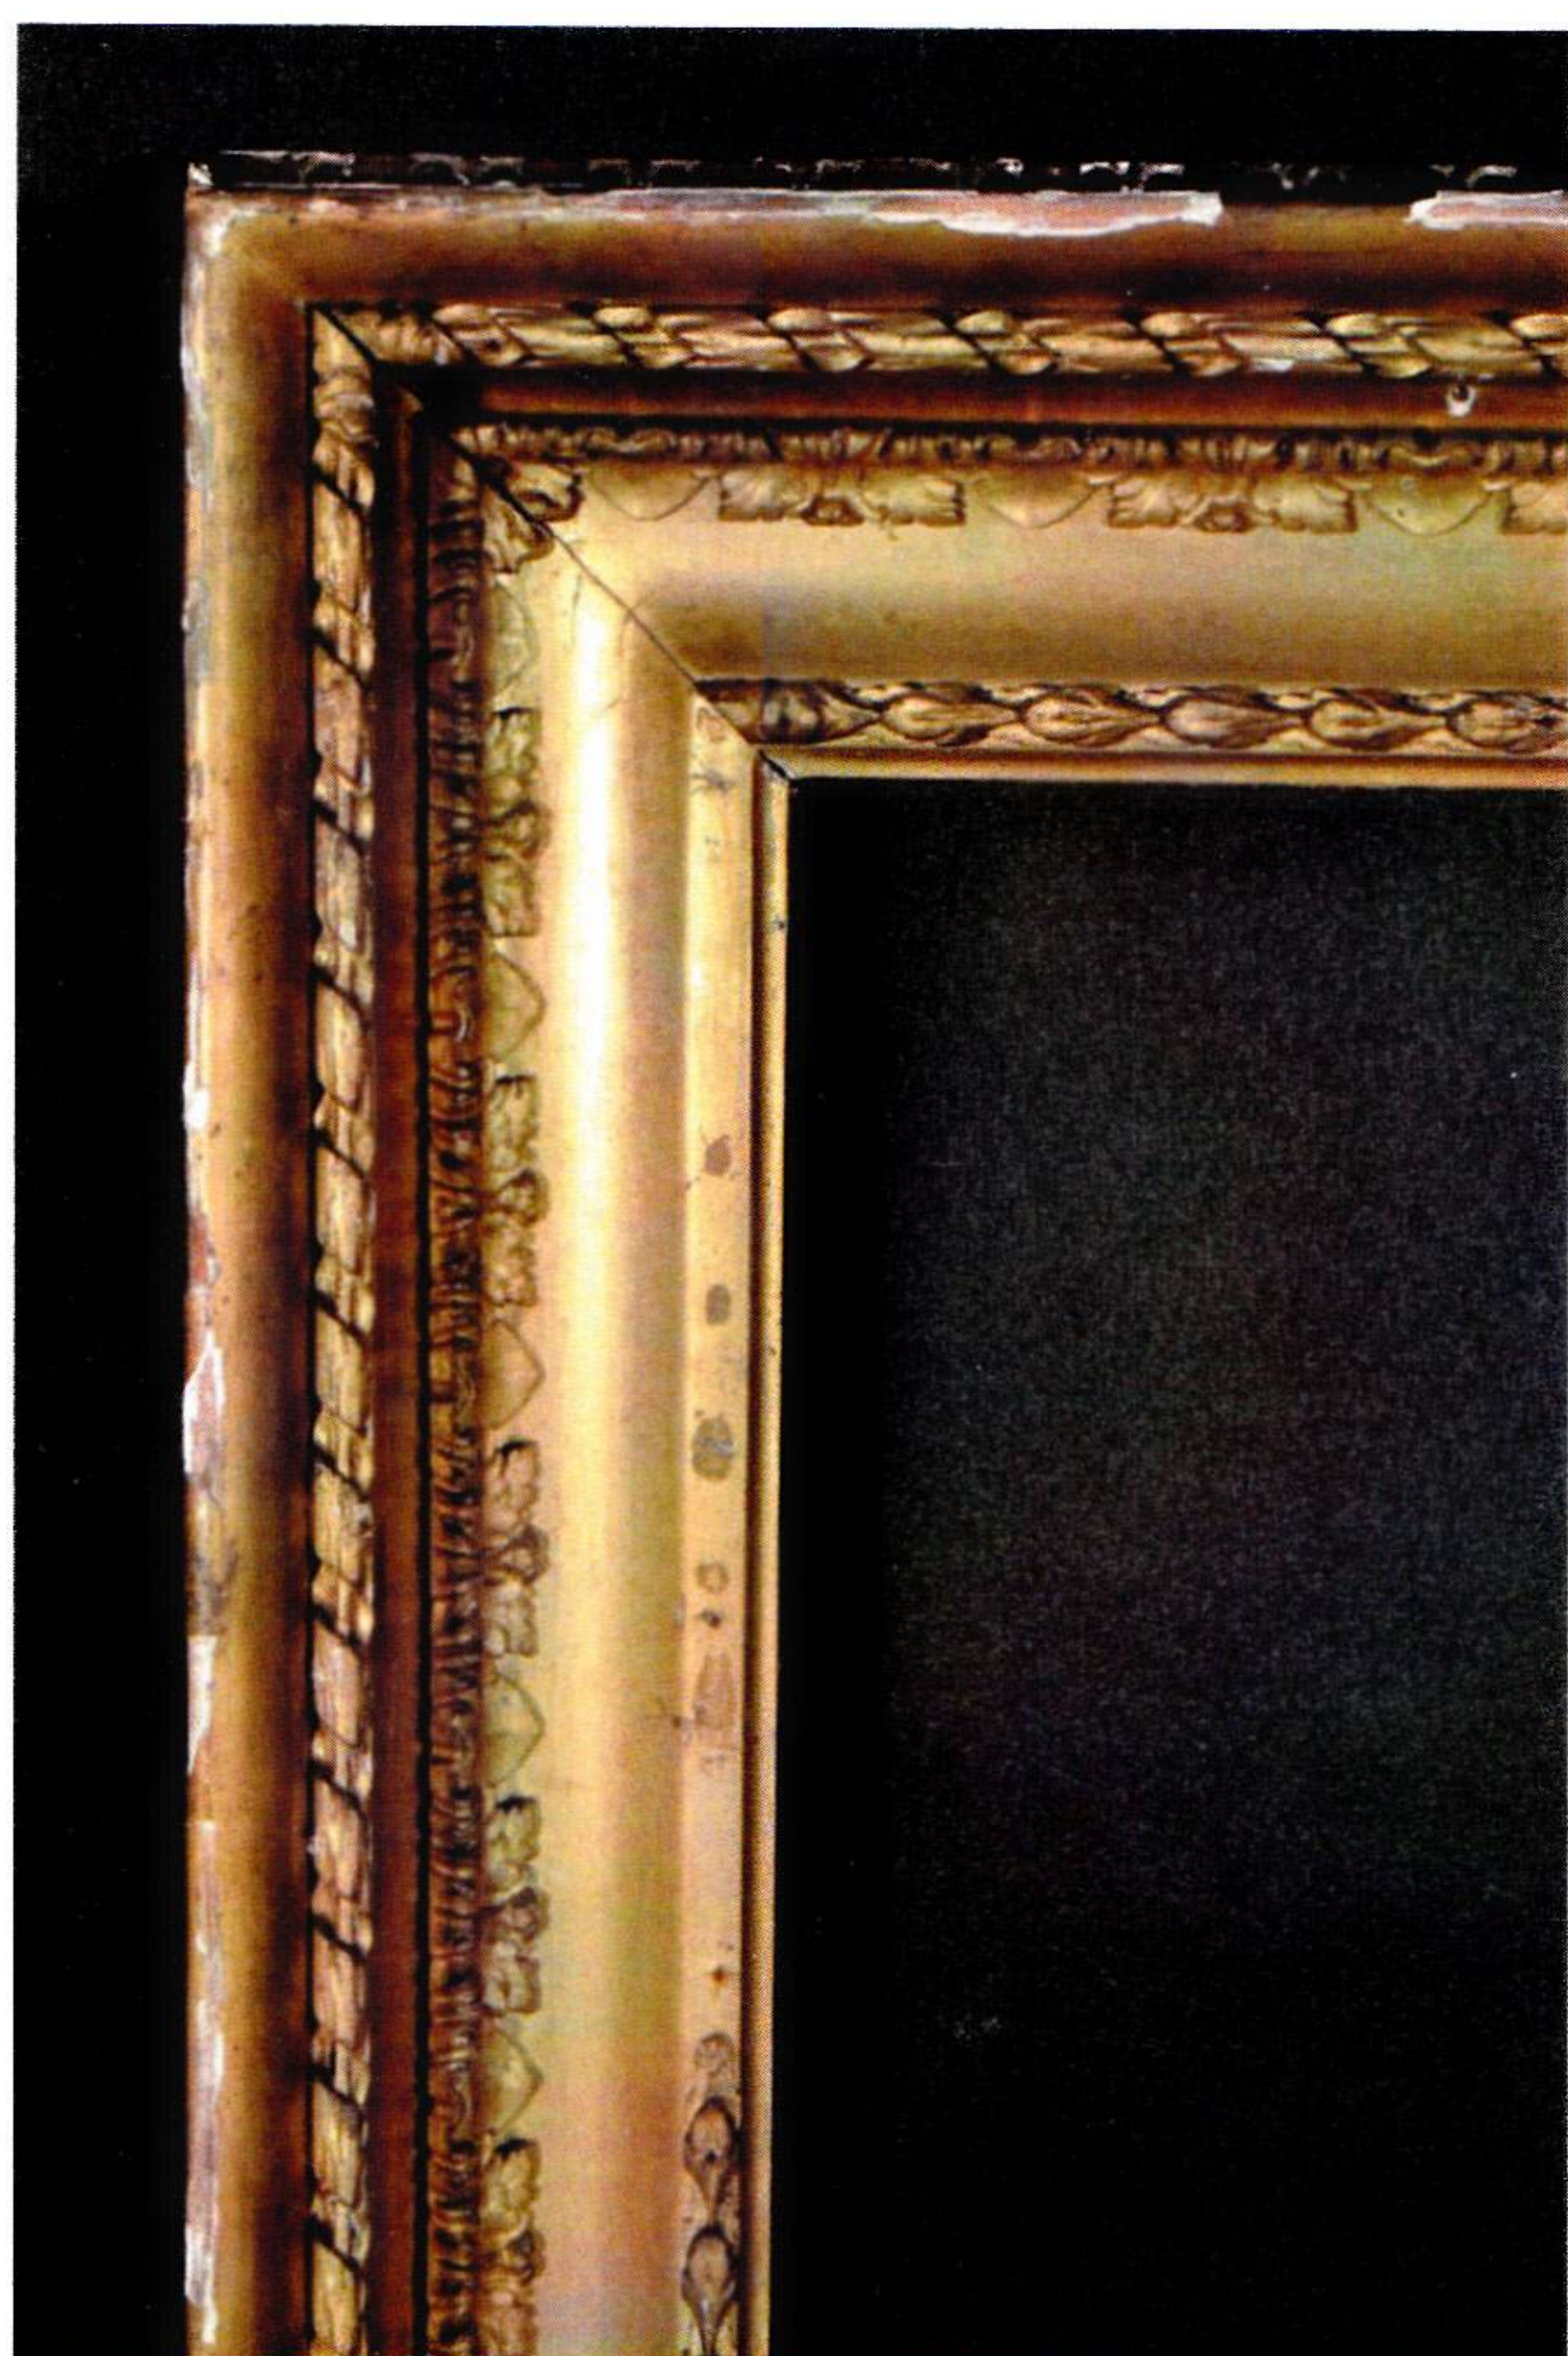
Close-up of the frame before conservation

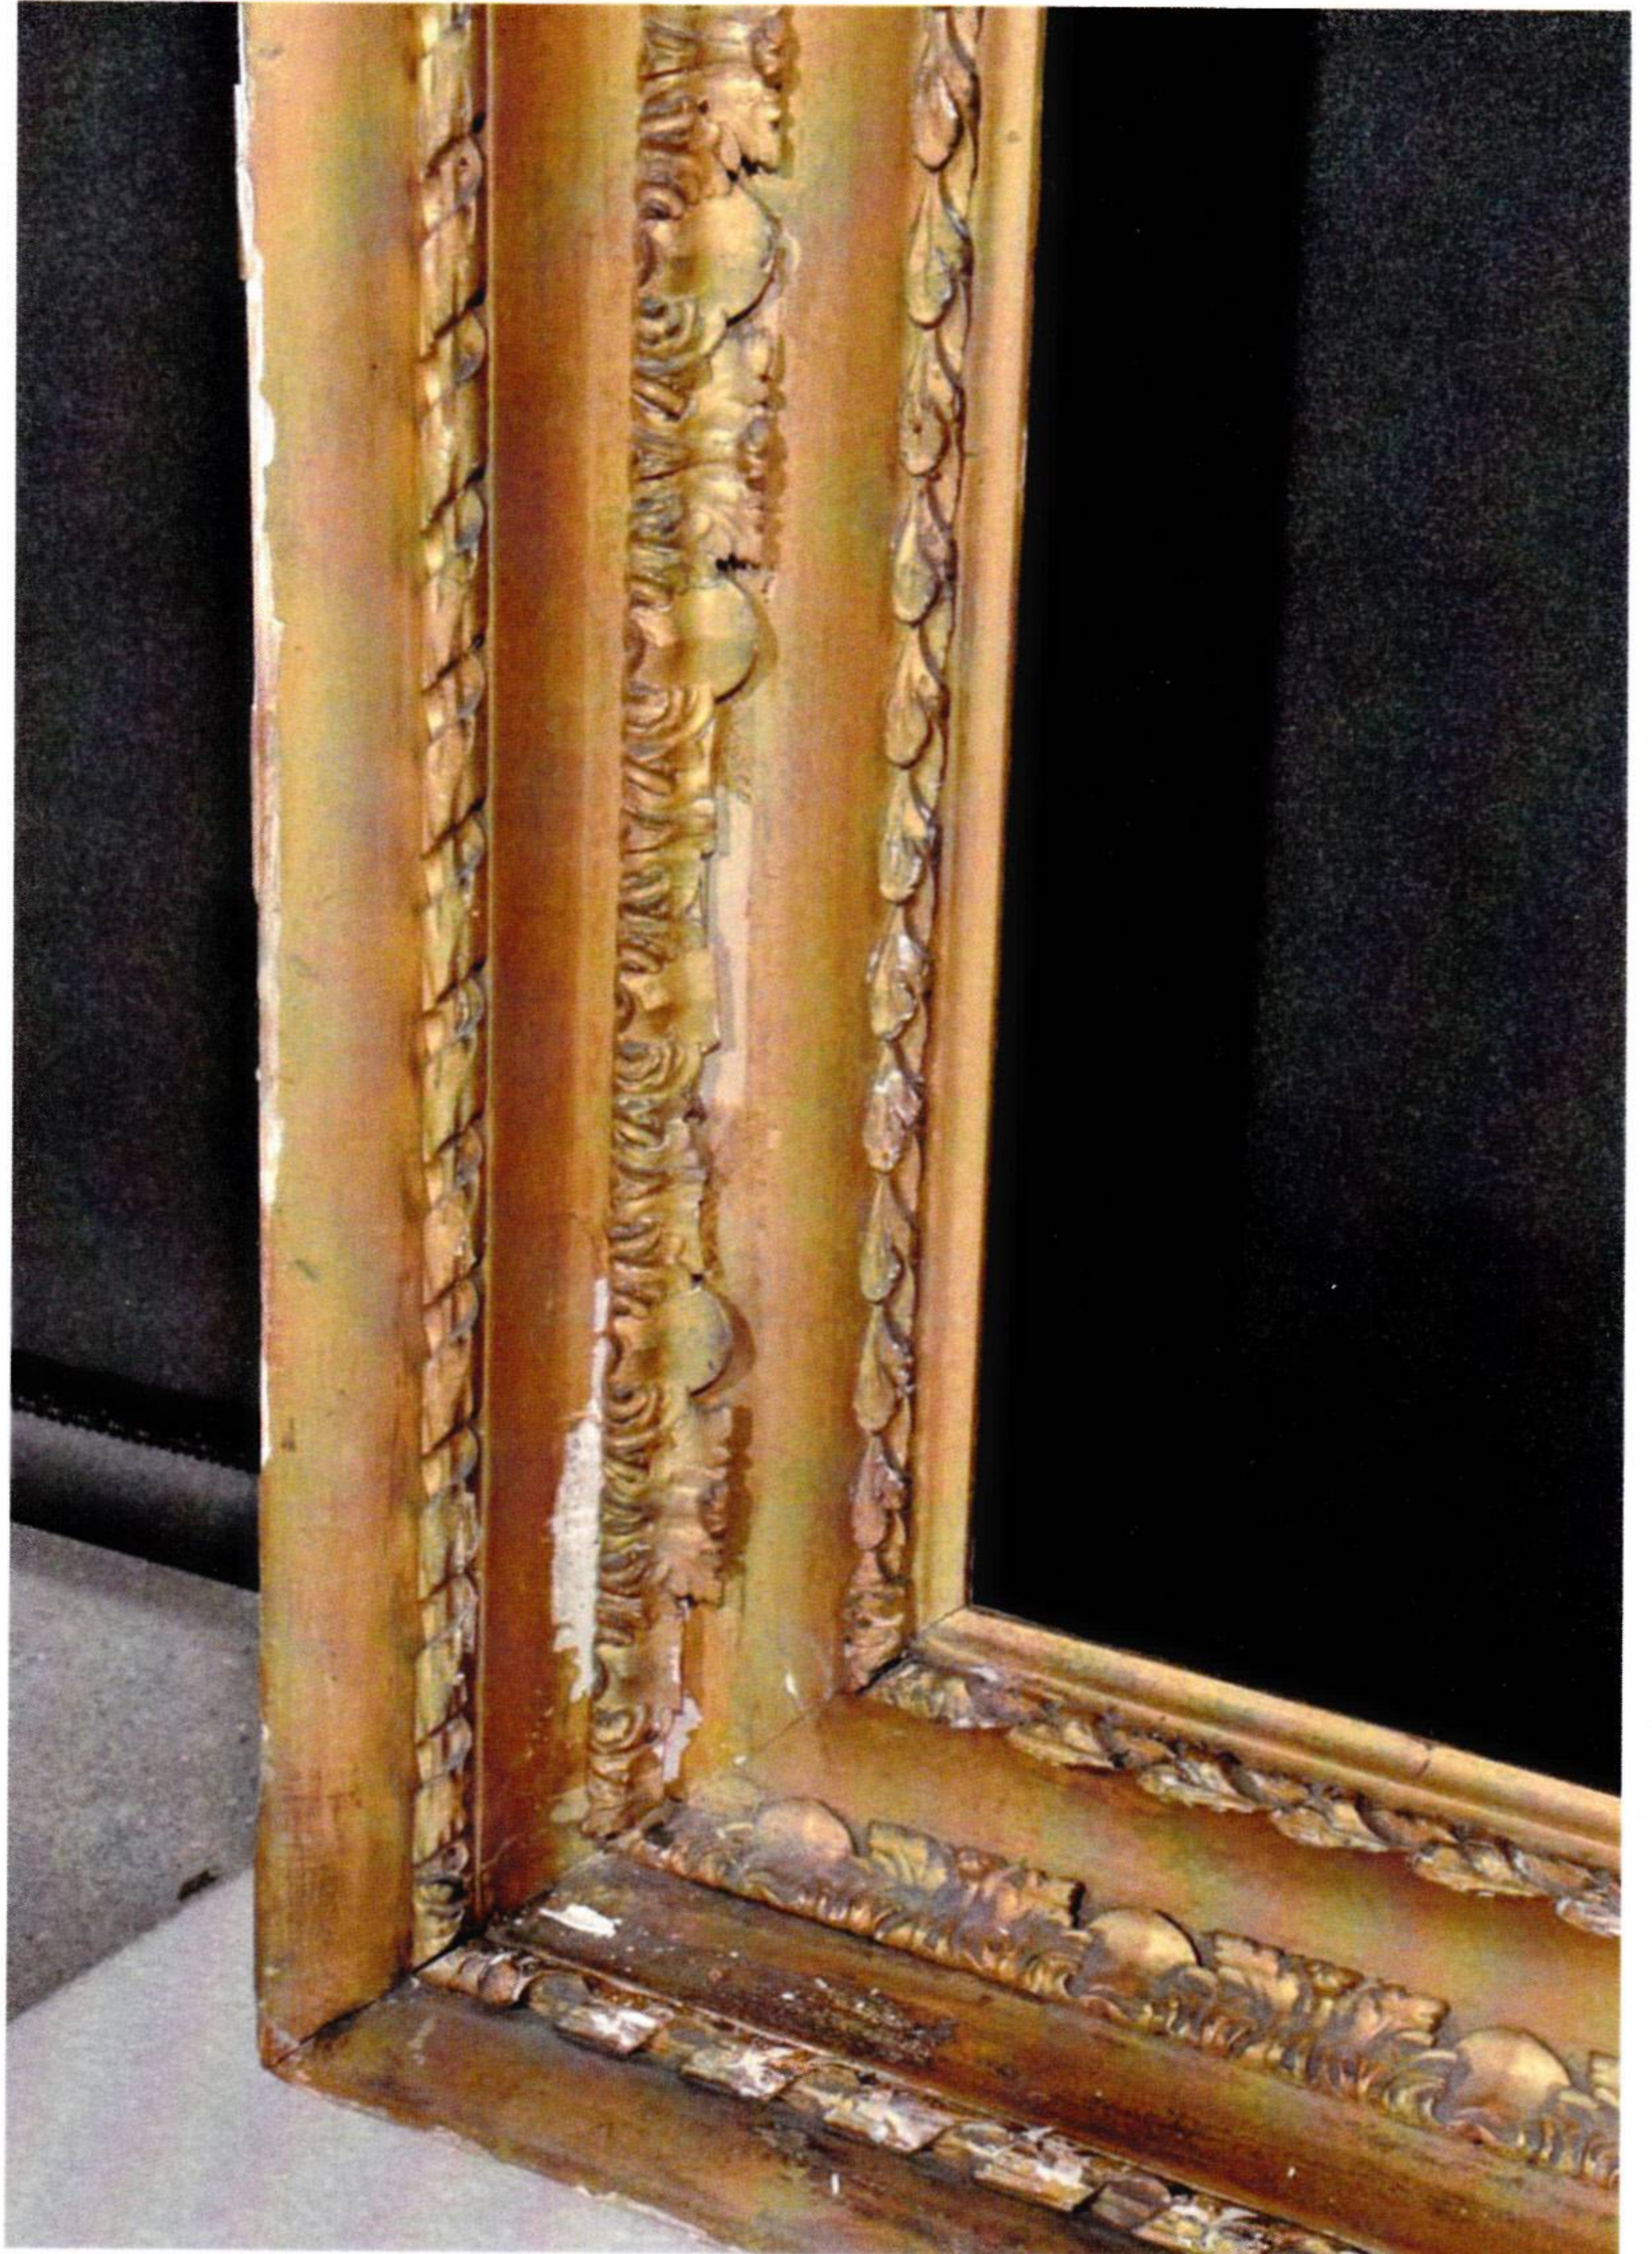
The frame was in a poor state of preservation. The surface of the front of the frame was completely covered with dust and grime which significantly disfigured the gilded finish. All nails securing the ornamental decoration were corroded and became weak resulting in partial detachment of the ornaments from the frame. For example: the overall loss of the olive ornament was around 74 cm. Also the acanthus-and-tongue ornament was detached along the left and right sections and the loose part was around 120 cm long. These damages were very critical as a rapid movement or change of the environmental conditions could break the decoration or completely detach them from the frame. Closer examination revealed that there were several areas of substantial loss in the ornamental decoration. Extensive microflaking of the oil gilded finish was evident on most of the ornaments. The flaking was probably a result of insufficient sealant. Additionally the corroded nails accelerated the deterioration of gesso and gilding layers. Some surfaces had partially lost the original gesso and gilding so that the wooden support was visible. The most severe damages to the gilding finish were observed in the front hollow near the bottom-left corner. The gold finish was severely delaminated with extensive losses and was characterised by a unique pattern of cracks. This type of damage was caused by contraction of the natural glue applied during the previous renovation in order to attach loose, decorative pattern to the frame profile.

Close-up of the frame before

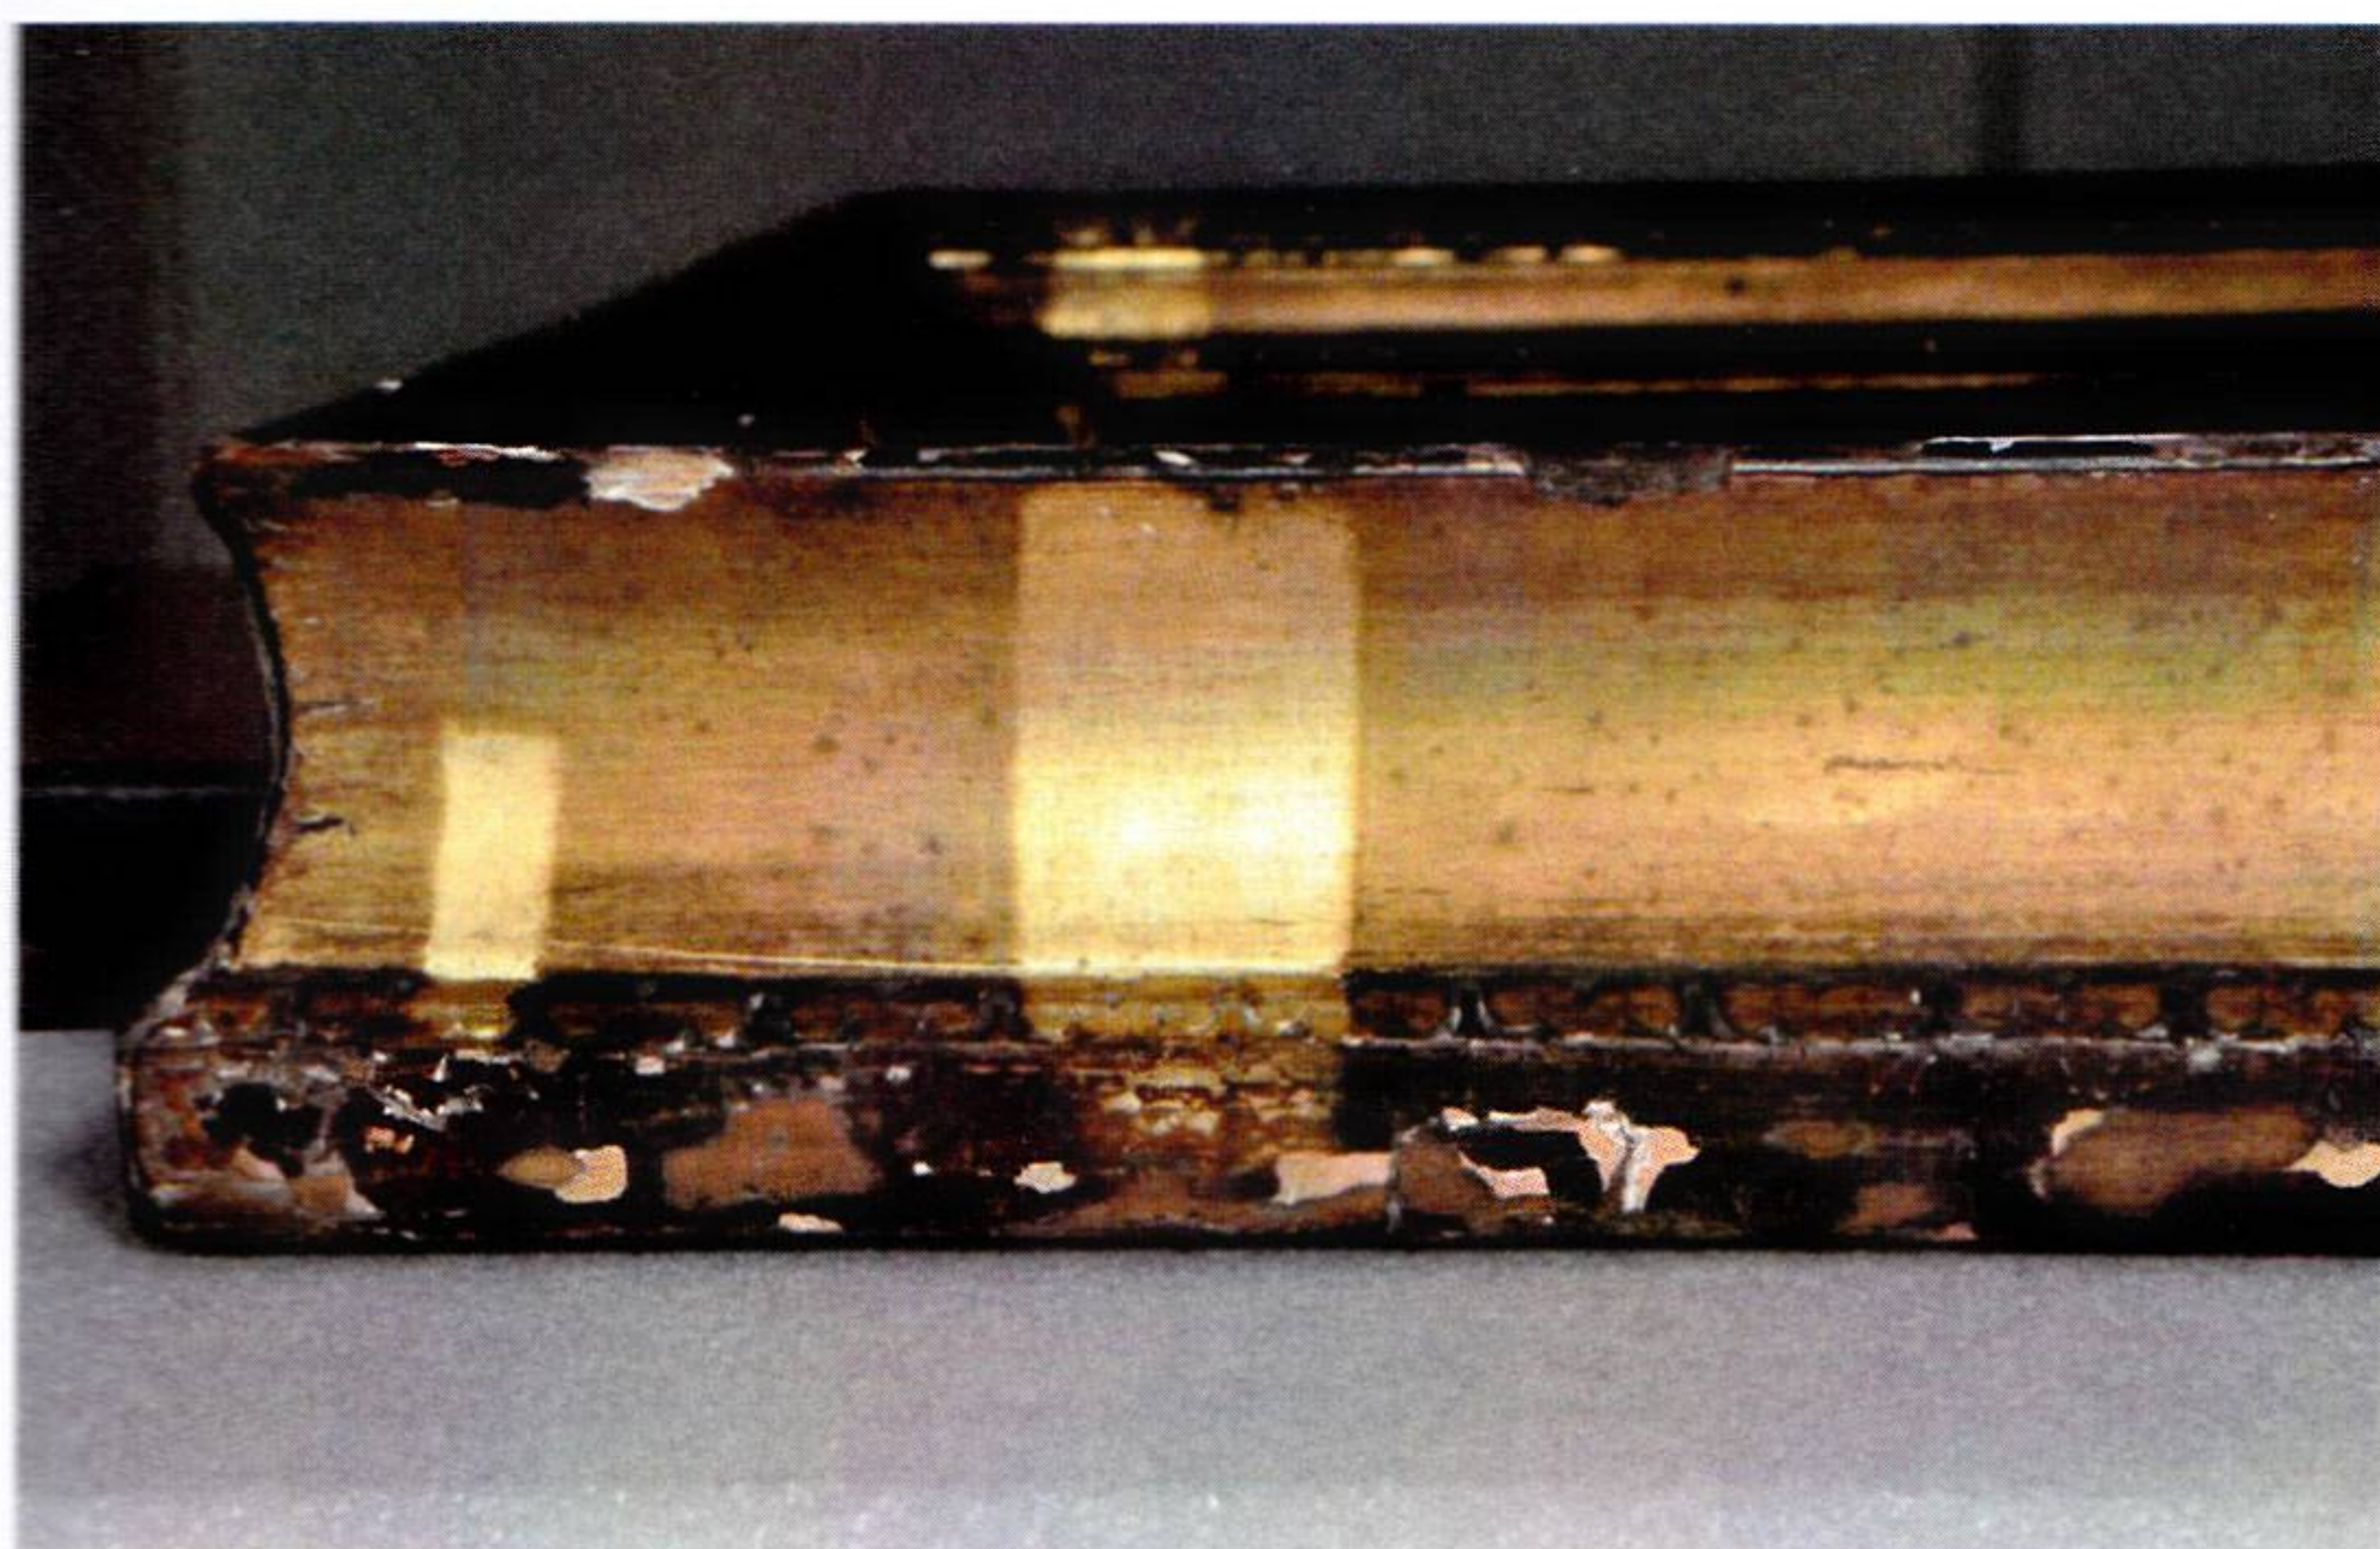
Frame during surface chemical cleaning tests

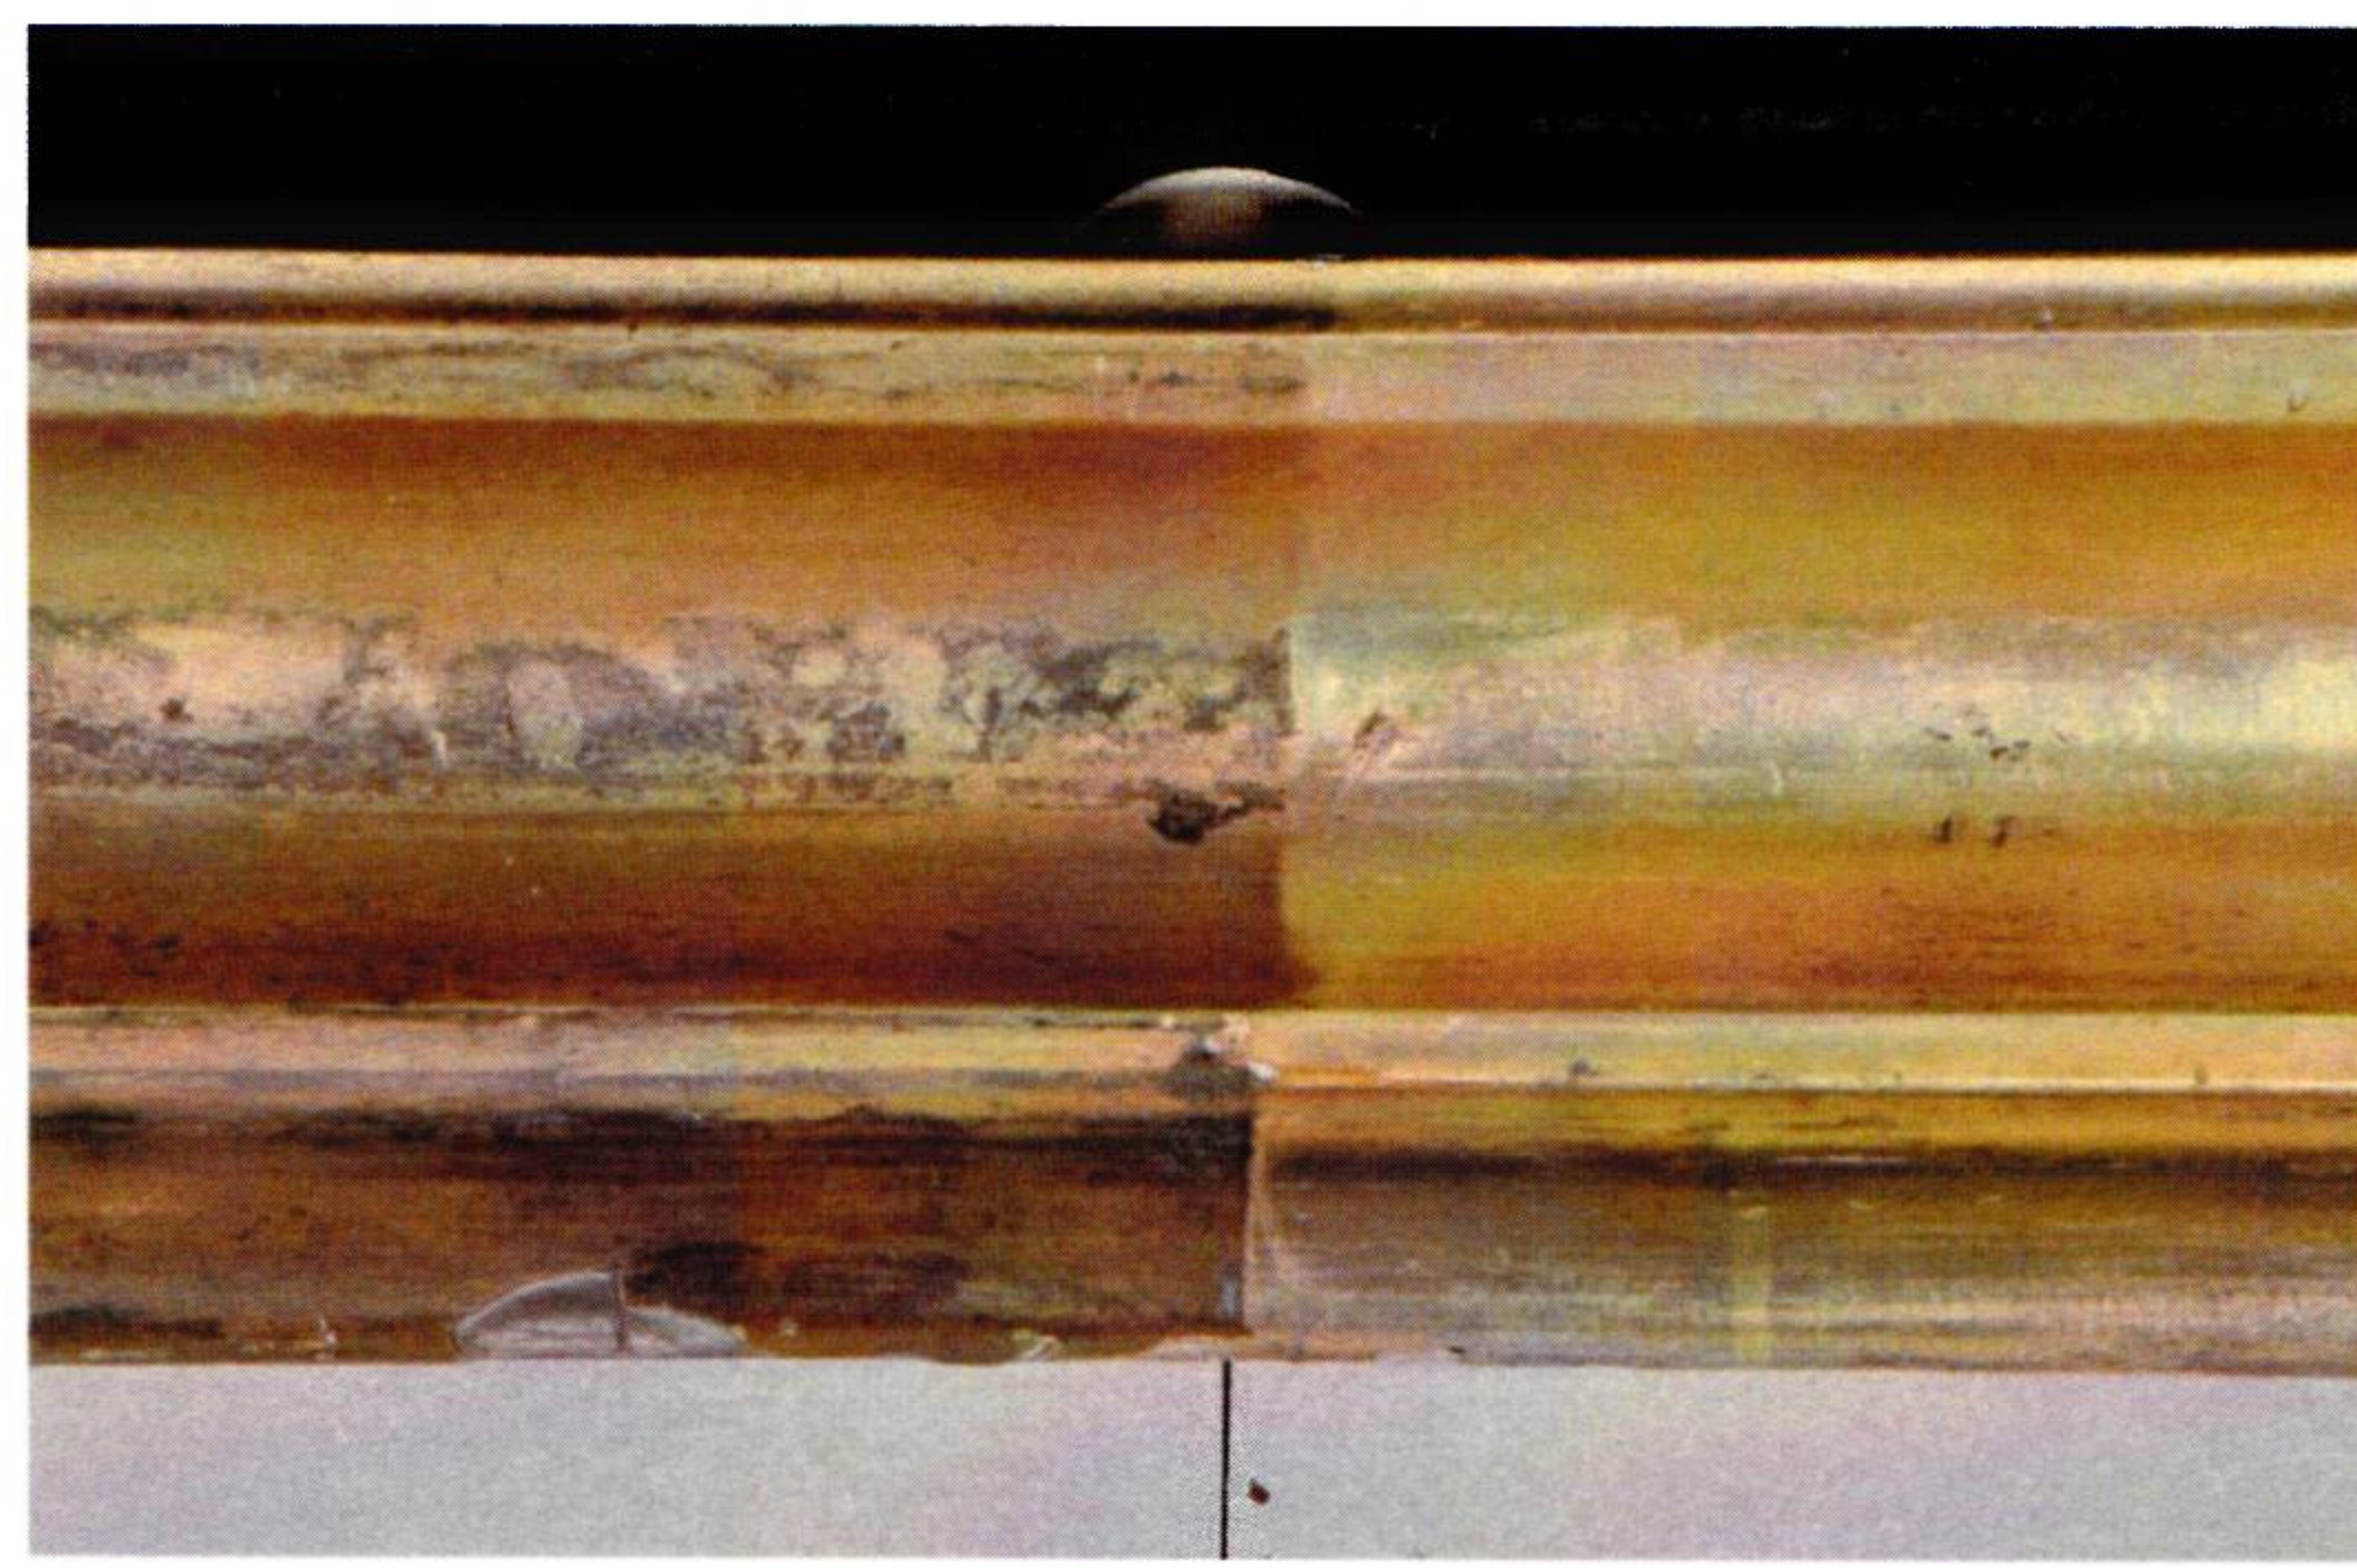
Frame during dirt and bronze over-painting removal

The conservation treatment began with a gentle cleaning of the frame. Loose surface dust was removed by dry cleaning with a soft brush under low powered vacuum. Next the decoration patterns were gently detached from the frame profiles. All nails were extracted from the frame profiles and decoration. Areas of detached gesso were stabilised using 6% solution of hot rabbit skin glue. Methylated spirit was used as a wetting agent to facilitate the penetration of the consolidant by improving capillary action and thus the ingress of the adhesive into the cracks. Further cleaning of the wooden surfaces of the back of the frame was achieved using 15 % Vulpex Liquid Soap in white spirit. The removal of bronze over-painting from the top edge was achieved using Nitromors Paint Remover which doesn't affect a water soluble surface. The surface dirt from the oil gilded areas was removed with 5% Triammonium citrate in distilled water. Losses of the gesso layer were degreased with acetone. After solvent completely evaporated the losses were then brushed with 3% hot rabbit glue to improve adhesion to the new fills. Next, they were refilled with a new gesso made of calcium carbonate and rabbit glue. In the following stage all fills and selected areas of badly worn gold leaf and grey bole were prepared by application of a similar grey bole in 6% rabbit glue. The prepared surfaces were in-gilded in the traditional manner. Finally the top edge surface was burnished with the agate stone and toned in order to match the adjacent surfaces.

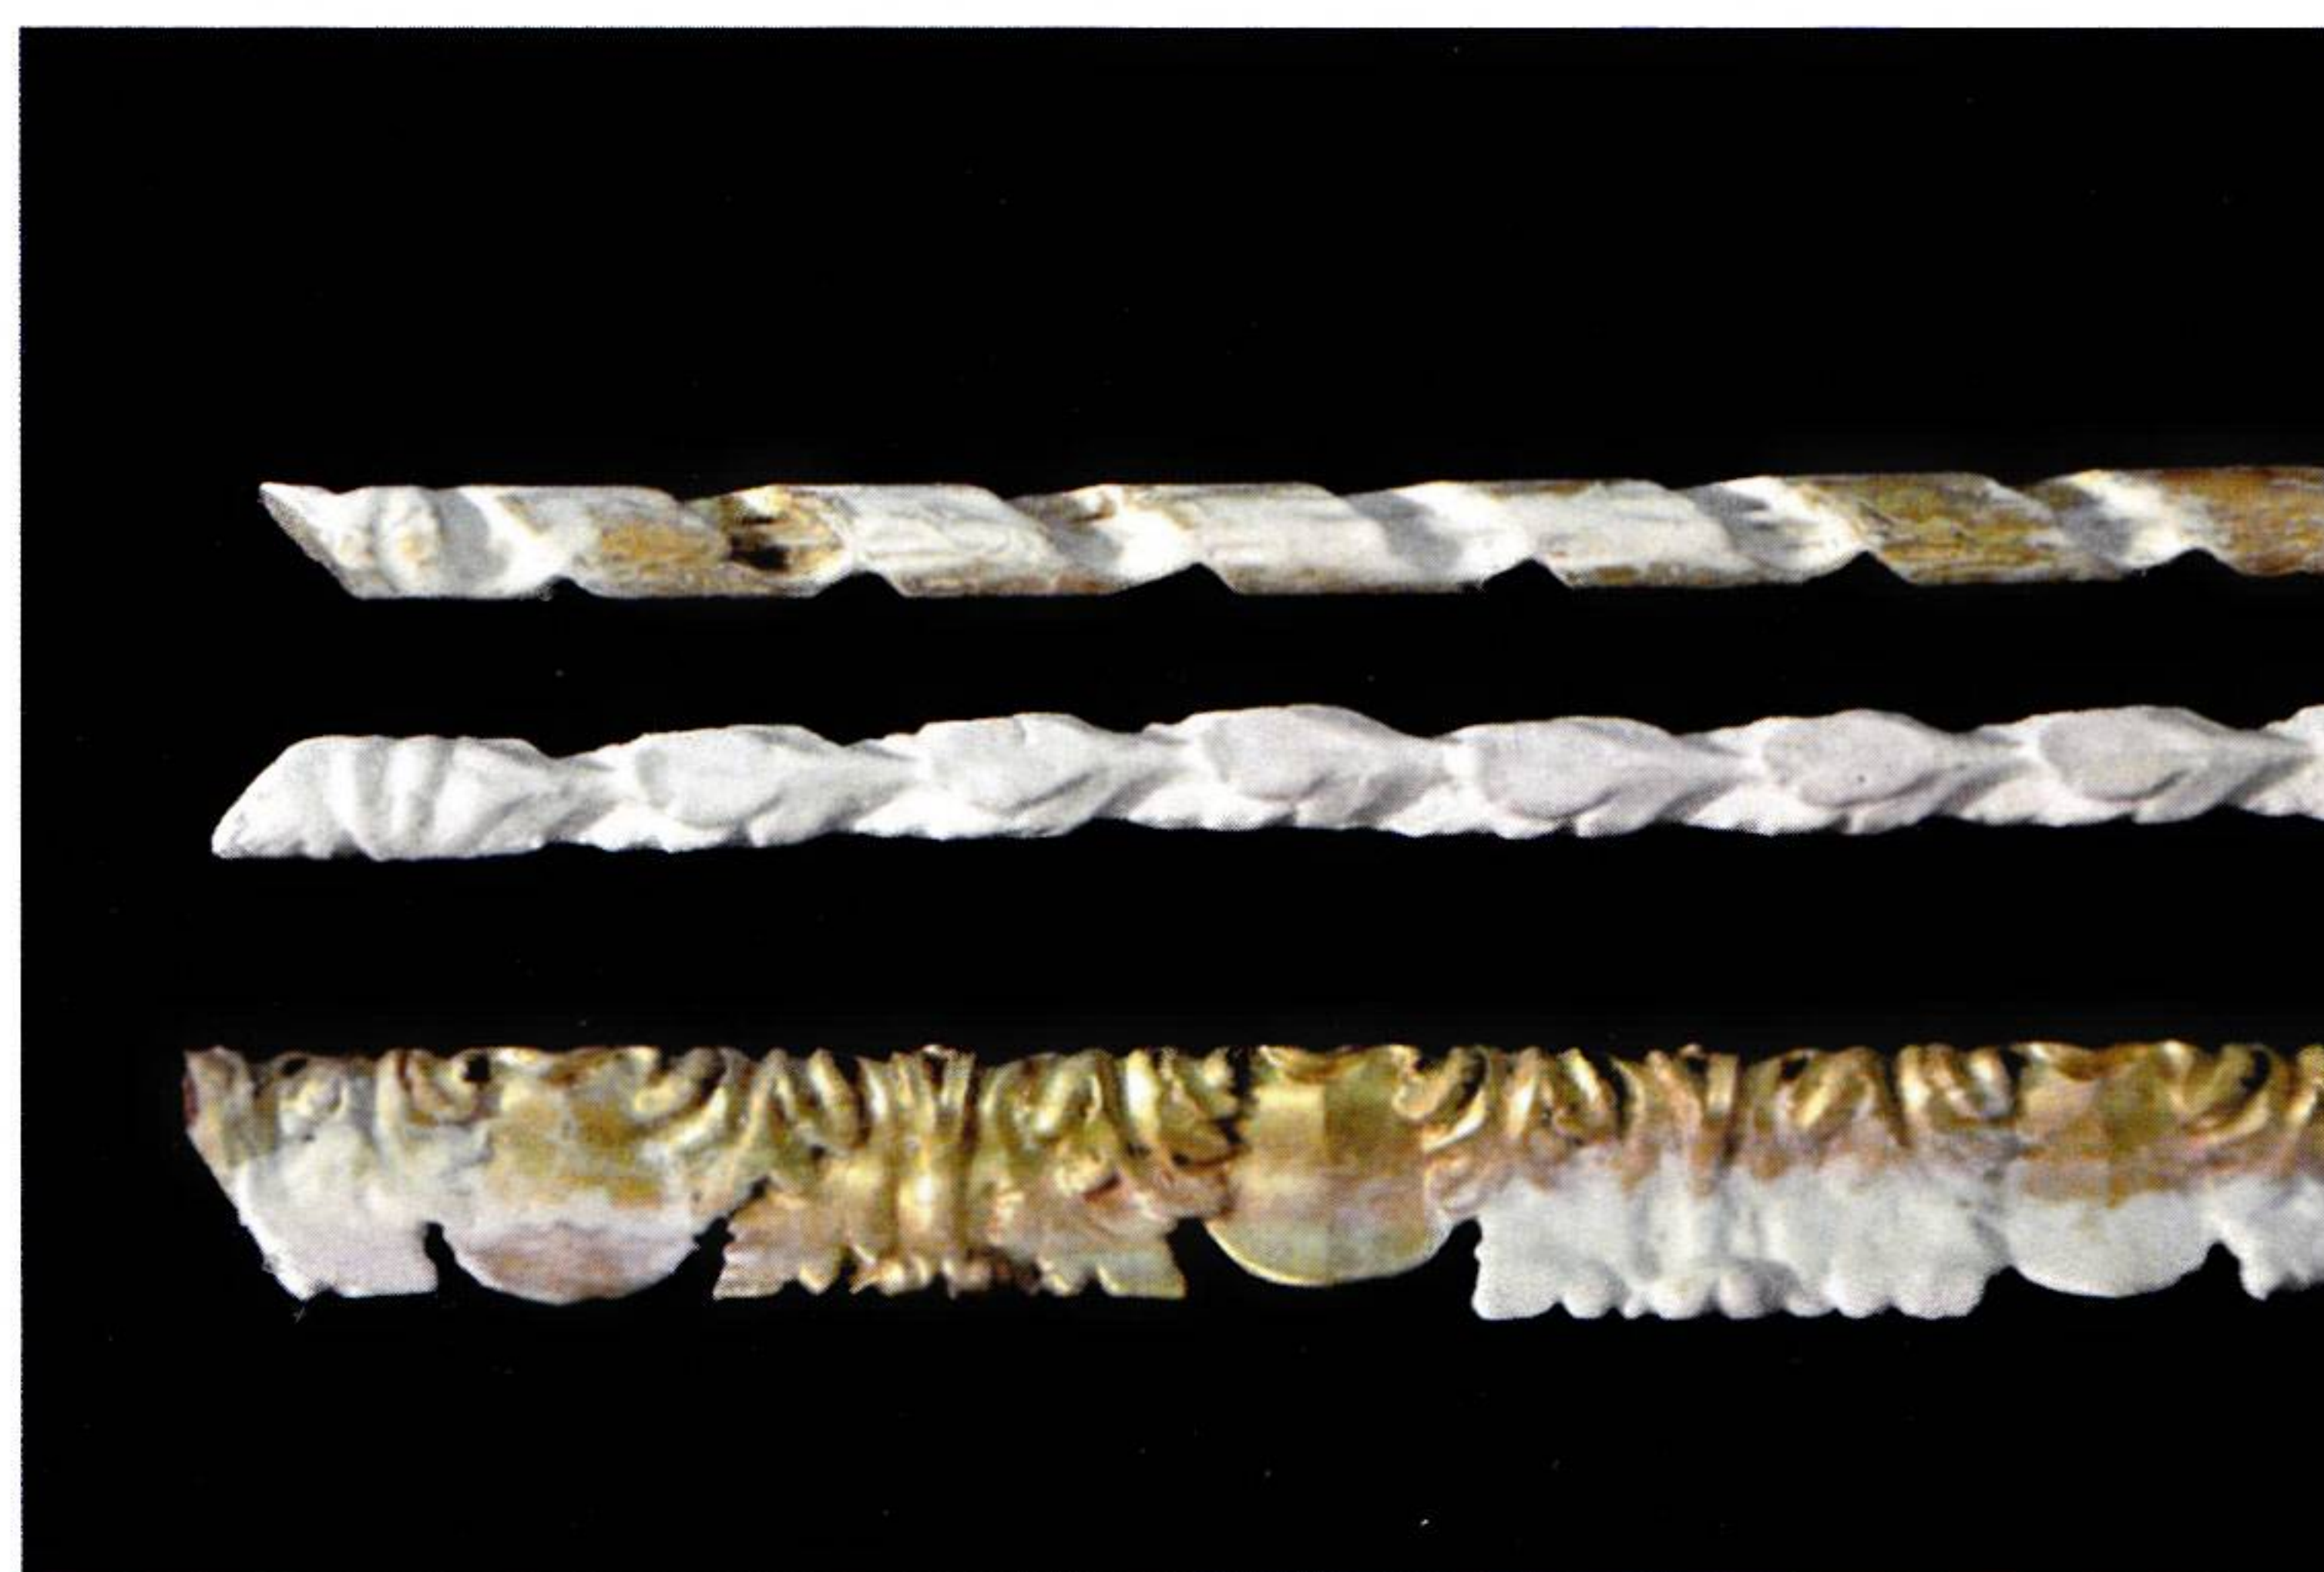
Close-up of the ornamental decoration after reconstruction works

The surface dirt was removed with 5% Triammonium citrate. Broken and loose fragments of the decoration were joined together using two-part epoxy resin Araldite AY 103 with hardener HY 956.

Missing details of the ornaments were replicated by carving and making silicone rubber moulds of the ornaments. Araldite 1253 epoxy paste was cast into the moulds to produce replacement parts.
