The examination and treatment of an eighteenth century picture frame, South Tipperary County Museum

Damian Lizun

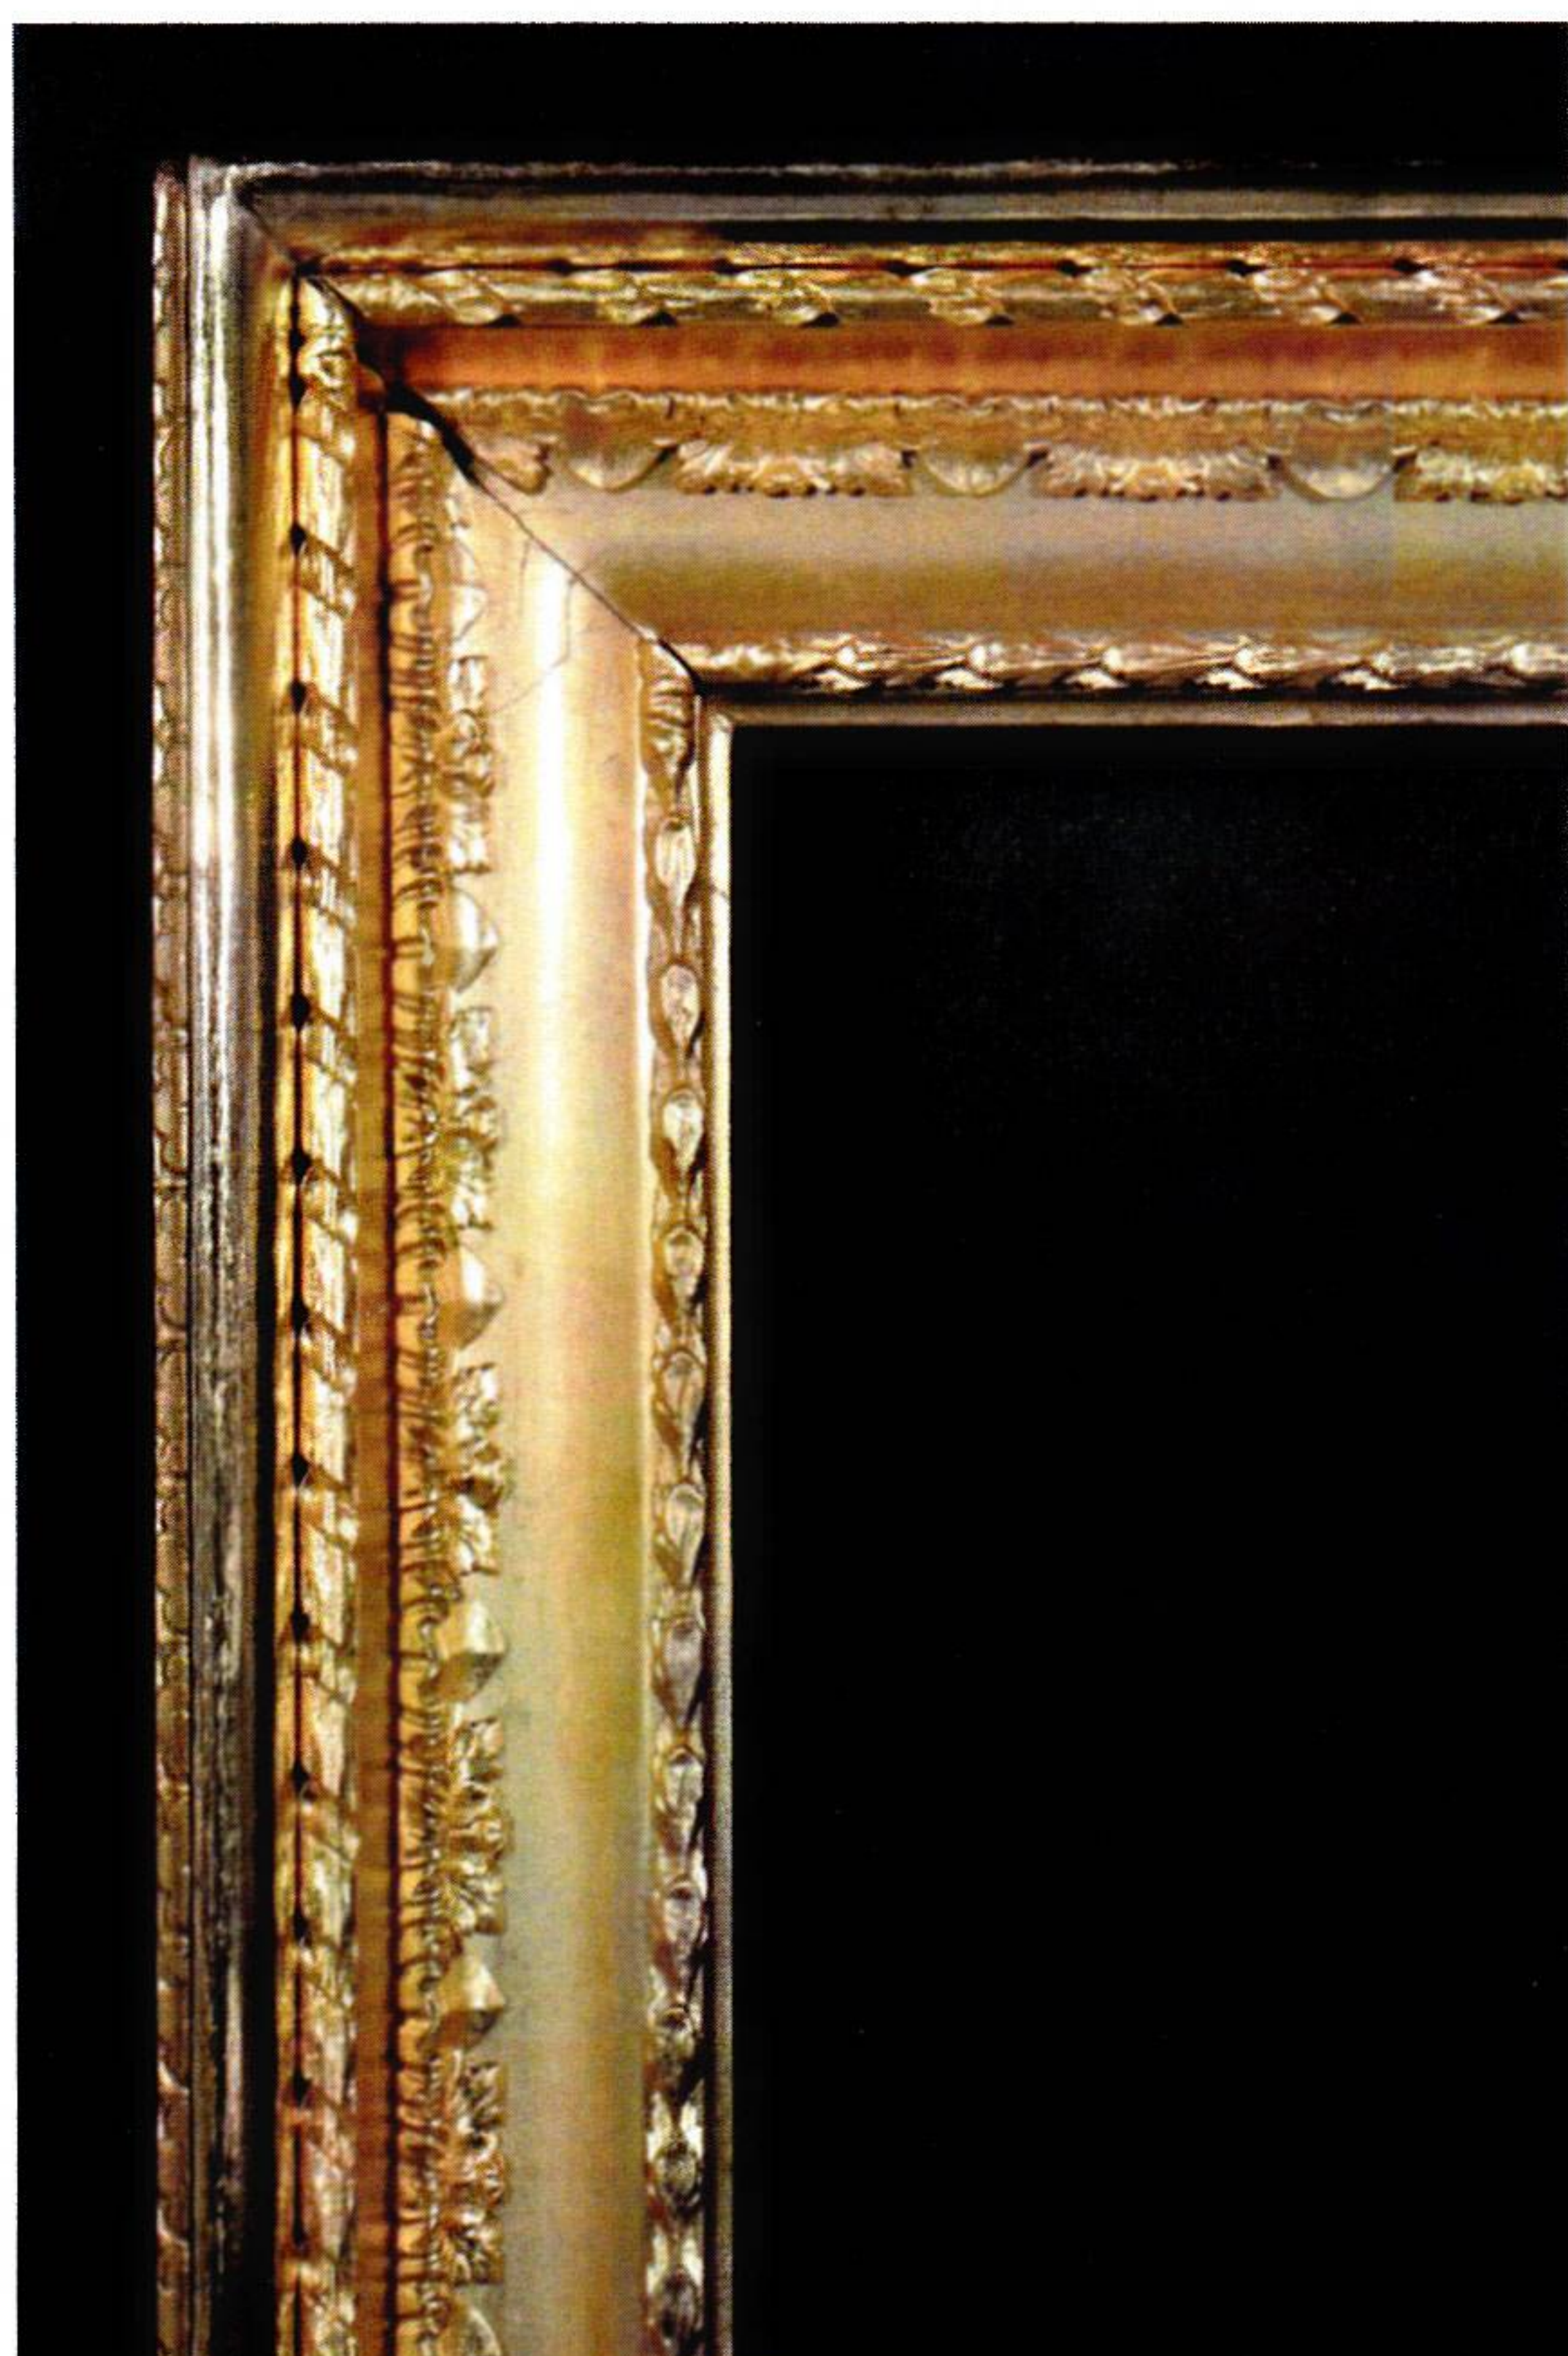
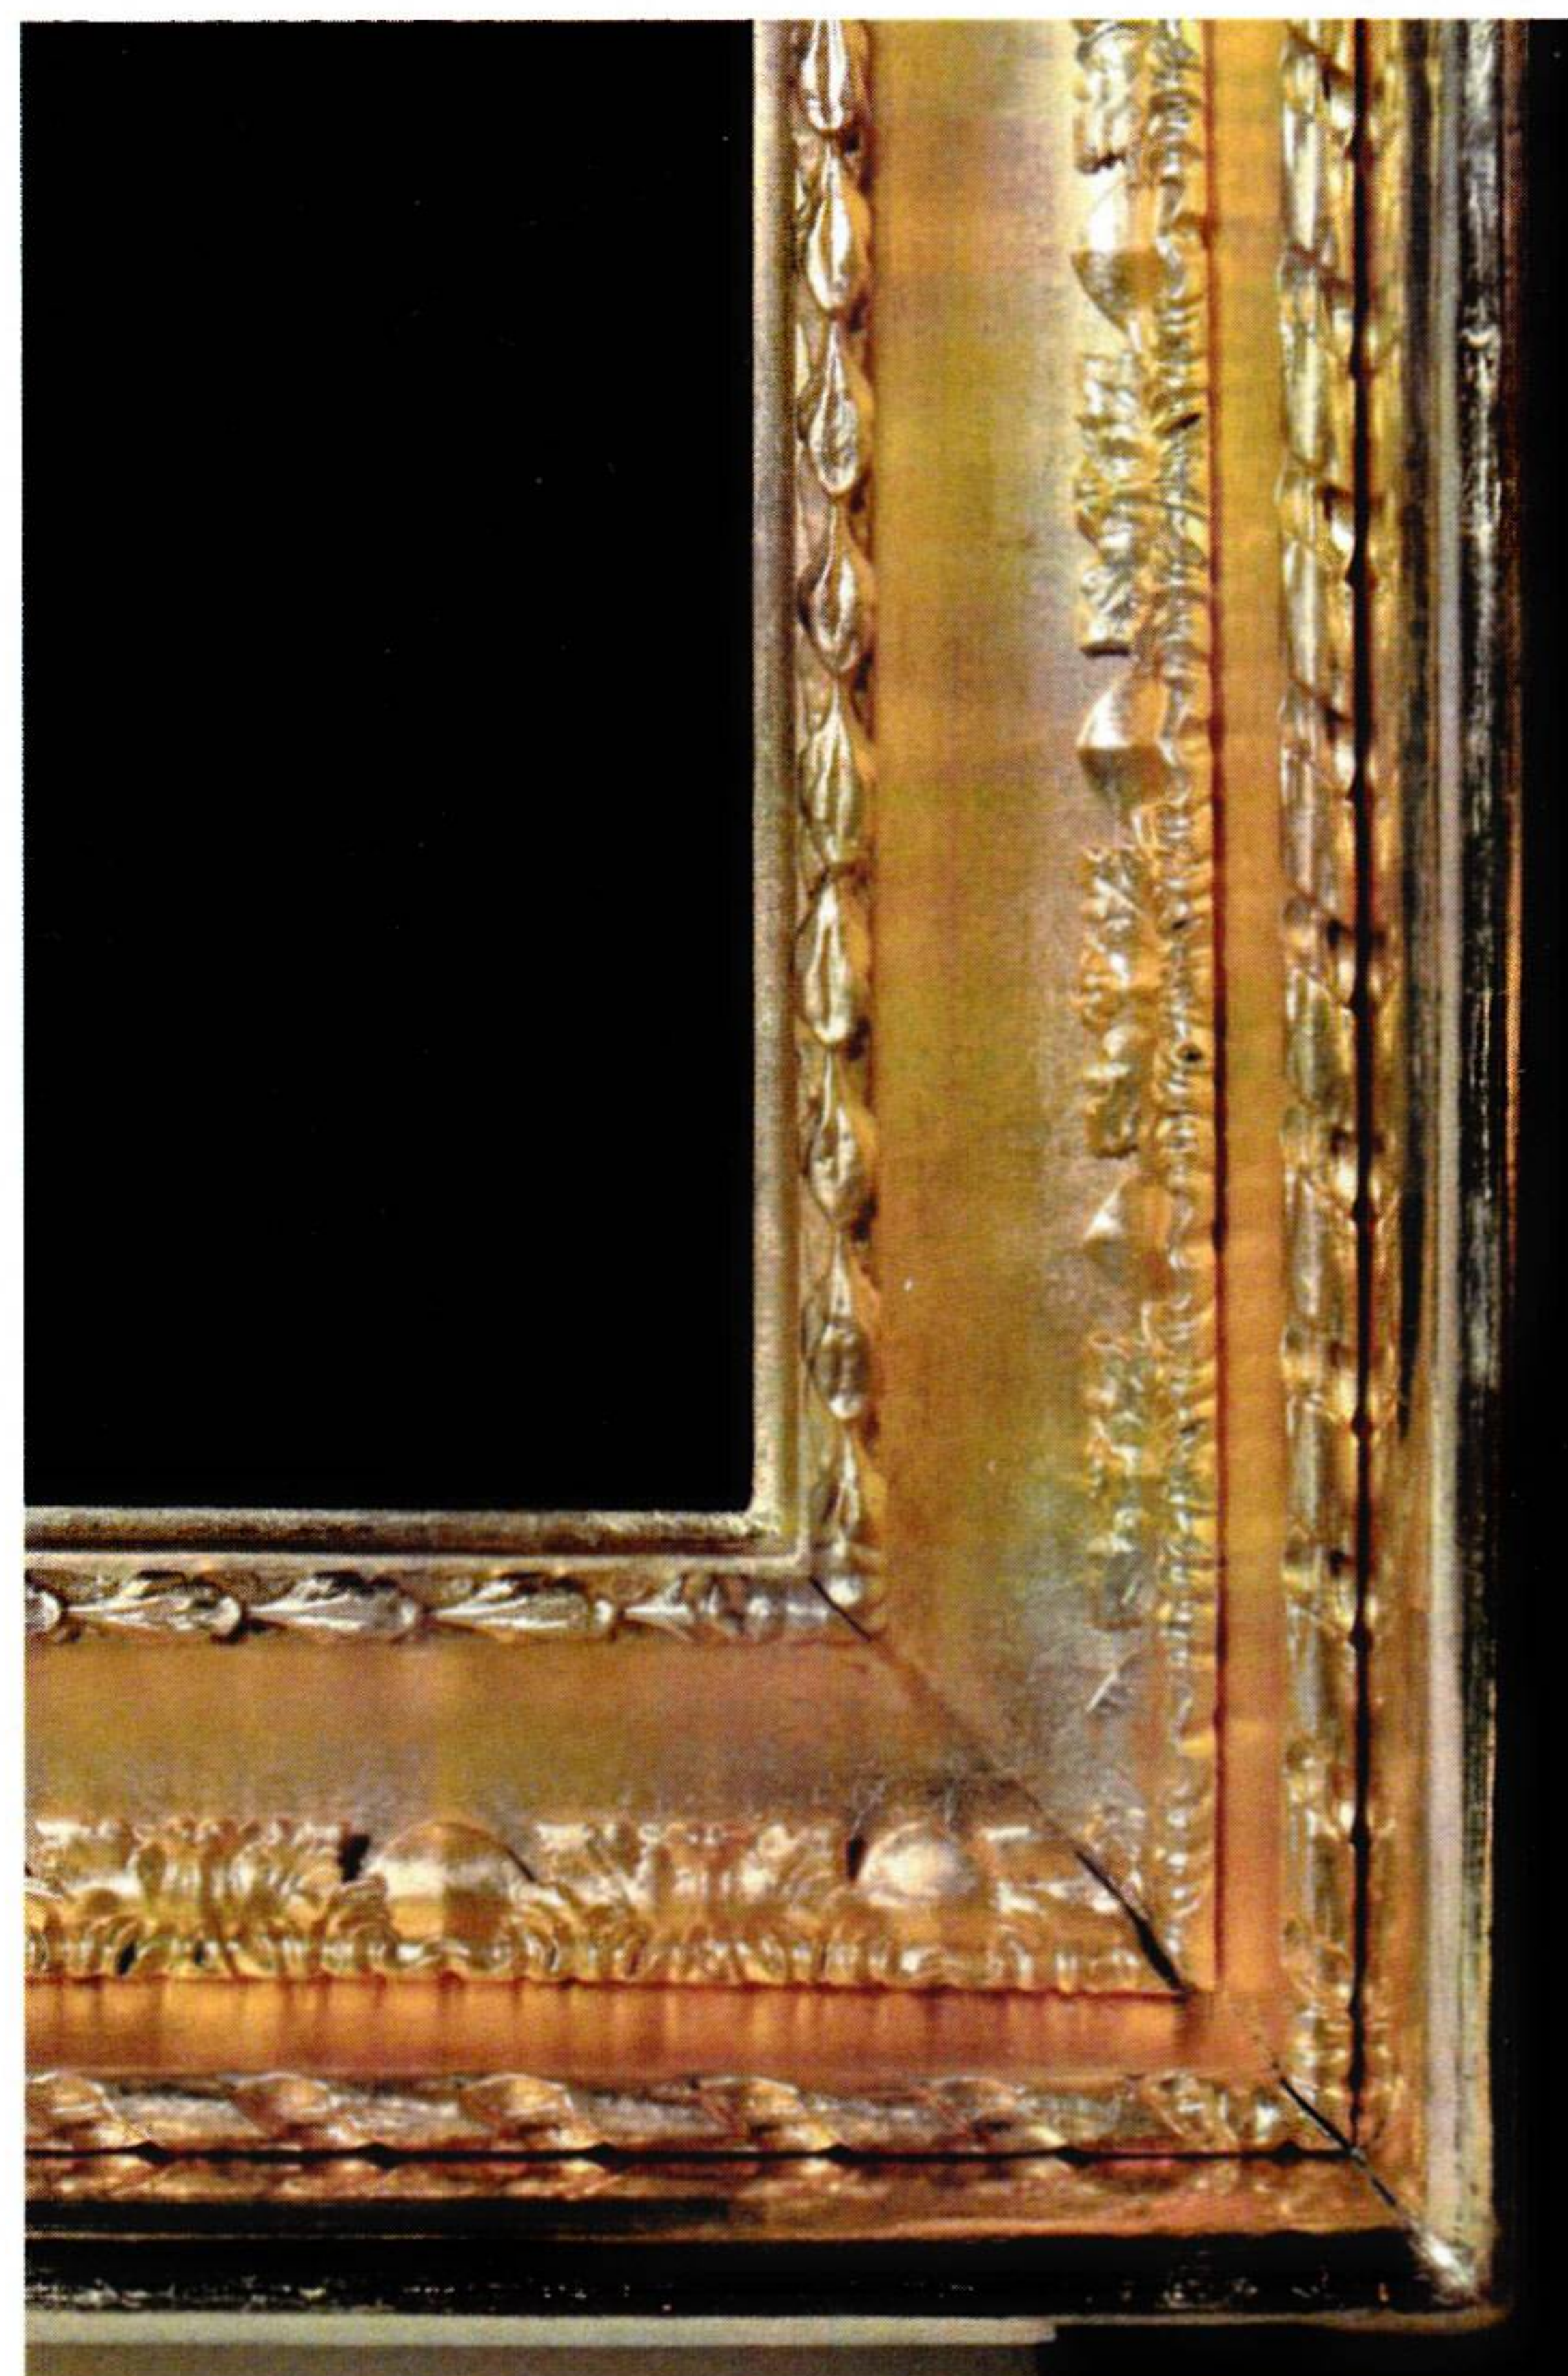
Close-up of the frame after re-gilding of missing areas

All replicated elements were given one coat of gesso and smoothed in preparation for gilding. Then the areas intended for gilding were brushed with acrylic paint yellow ochre and then sealed with shellac. A mixtion was brushed on and new gold leafs applied. Finally the ornaments were re-installed on the frame.
