BRITISH CARLO MARATTA PICTURE FRAME

technical examination and restoration process

> By Damian Lizun

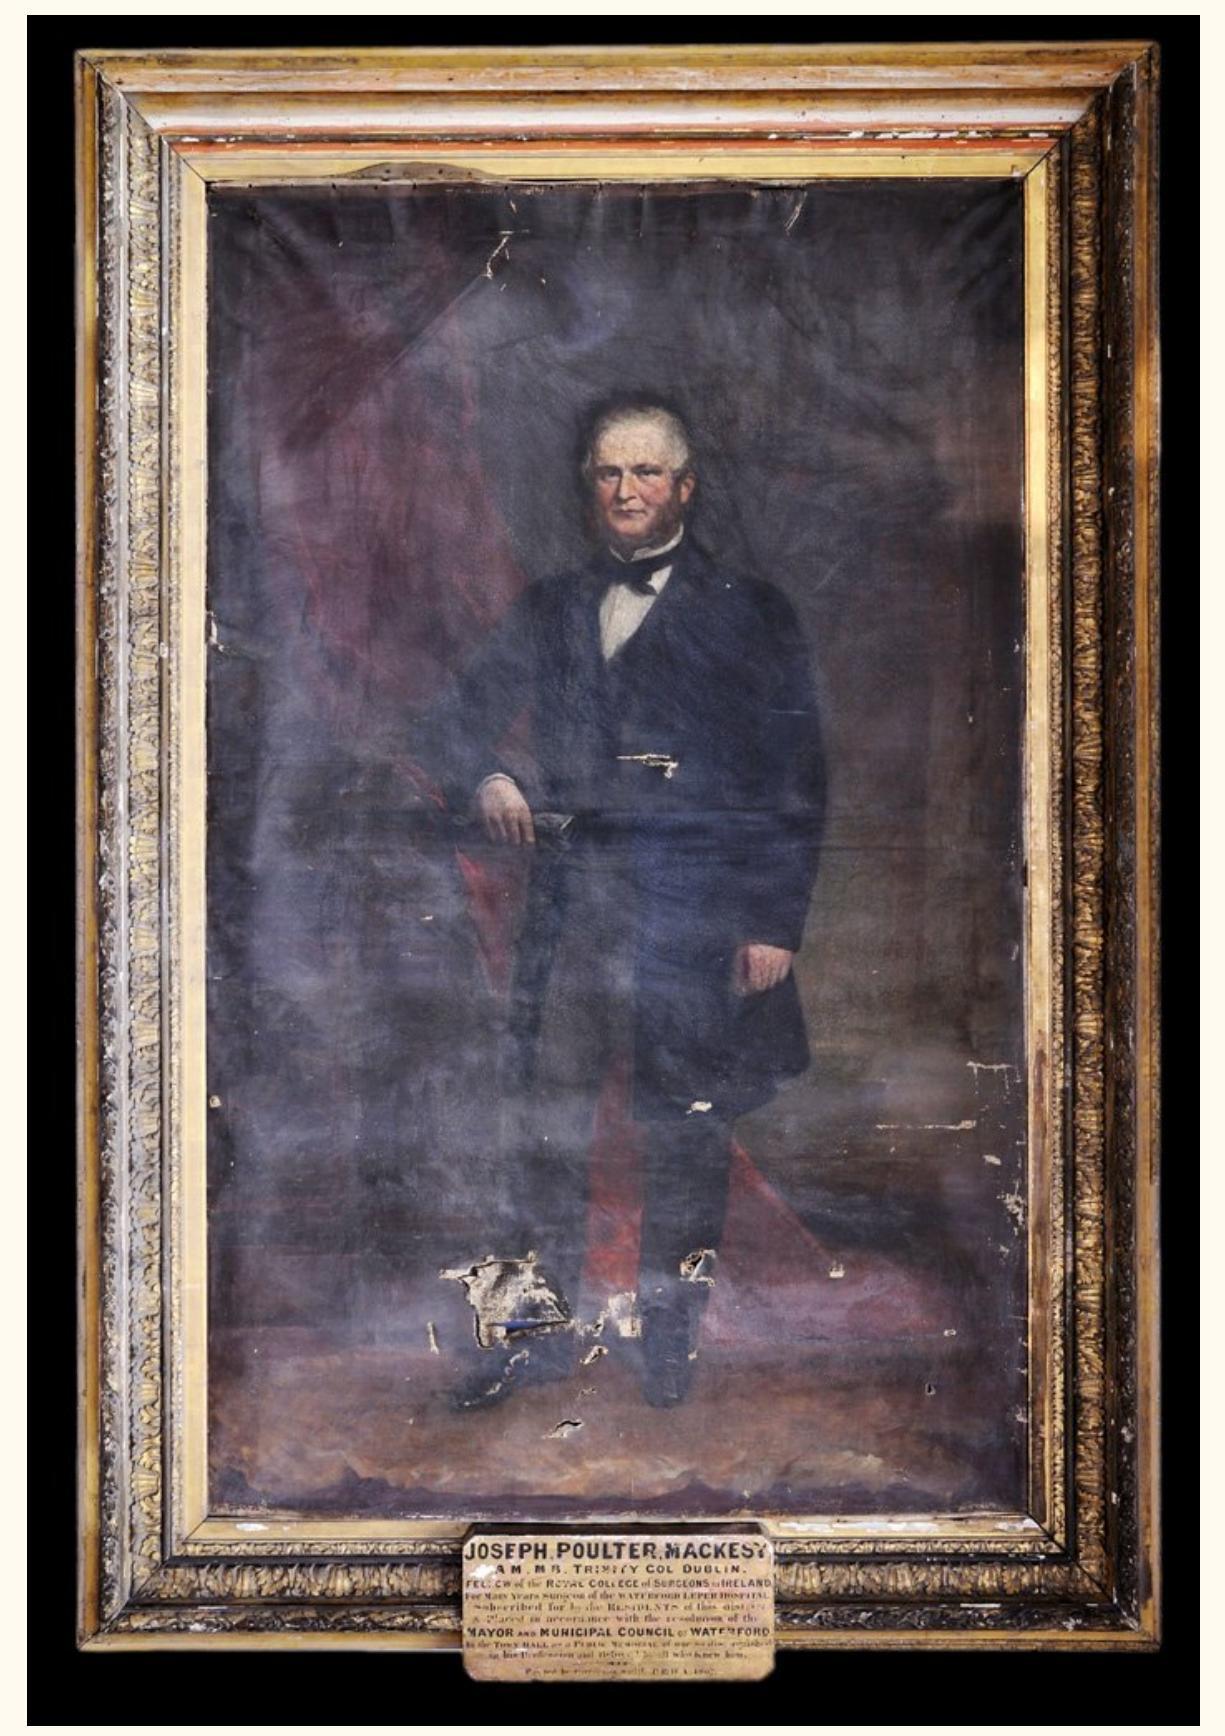
Figure 1. Carlo Maratta style frame dating from approximately 1867. The frame is original to the painting of Joseph Poulter Mackesy by Catterson Smith. The image shows the frame with painting before the intervention.

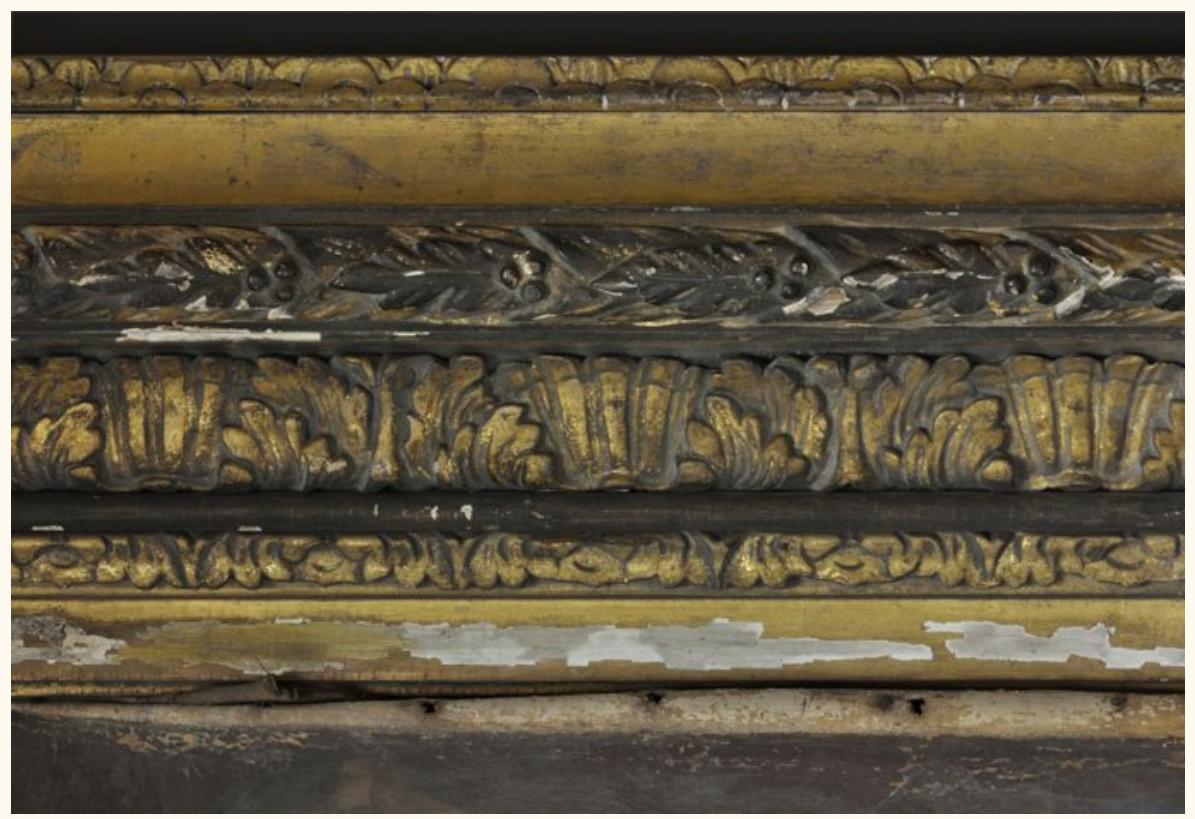
Figure 2. Detail of the top section of the frame before the intervention.

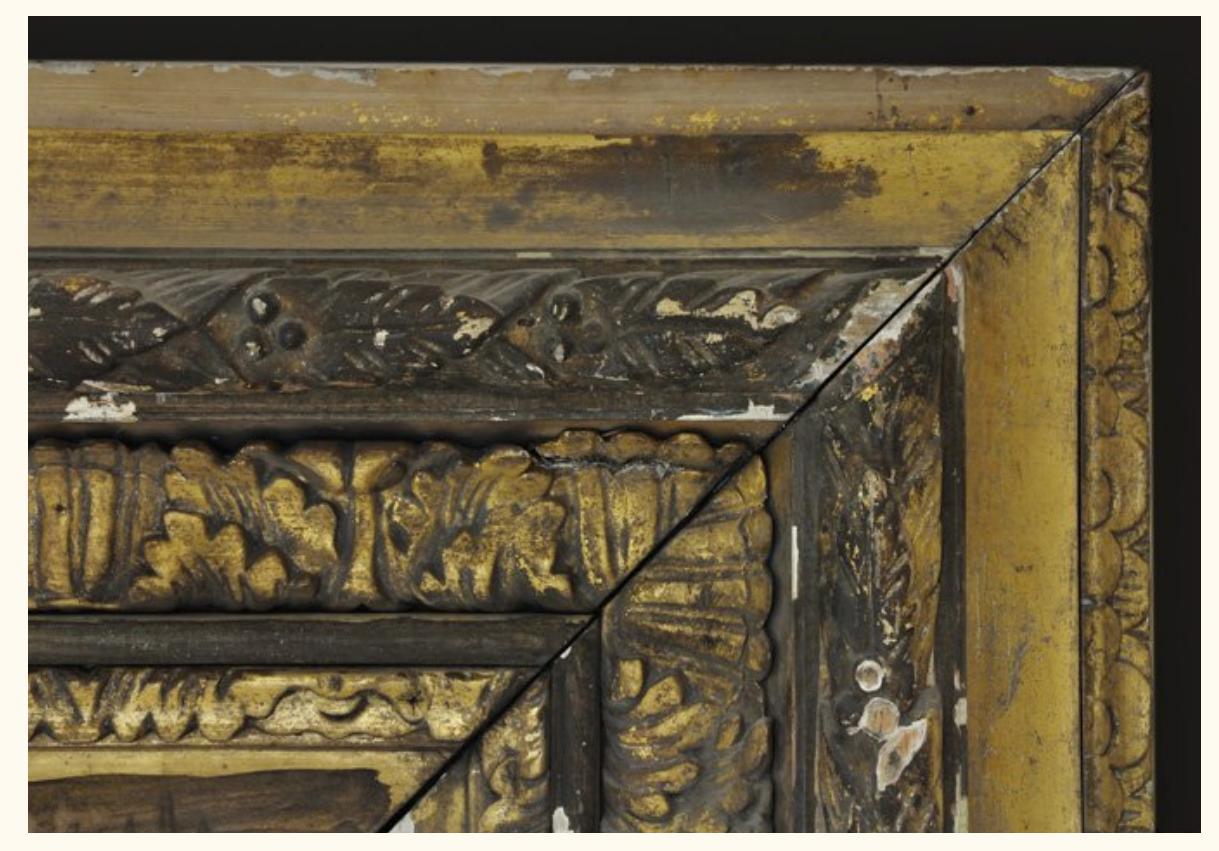
Figure 3. Close-up of the top-left corner of the frame before the intervention.

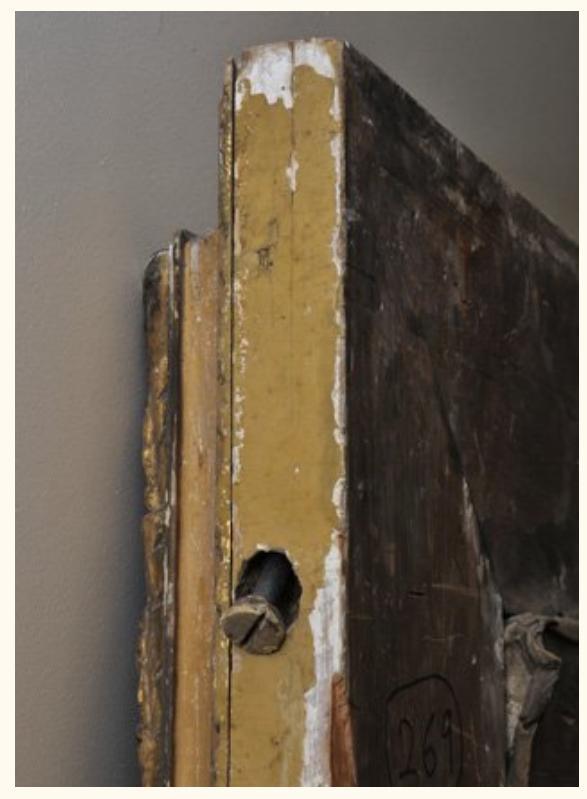
Figure 4. Detail of the bottom-left corner of the frame. The image shows the original, purpose made screw added across the mitre to secure the corner joint.

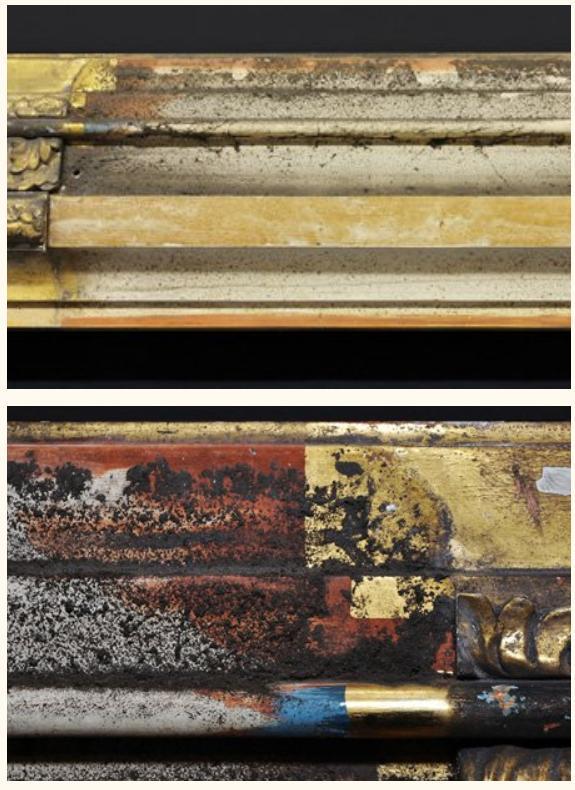
Figure 5 (above). Bottom section of the frame after dismantling of the plaque. The image shows the spectrum of all technological layers (wood-gesso-bole-gold leaf). Figure 6 (below). Close-up of the bottom section of the frame after dismantling of the plaque. The image shows the colour order of the bole layers.

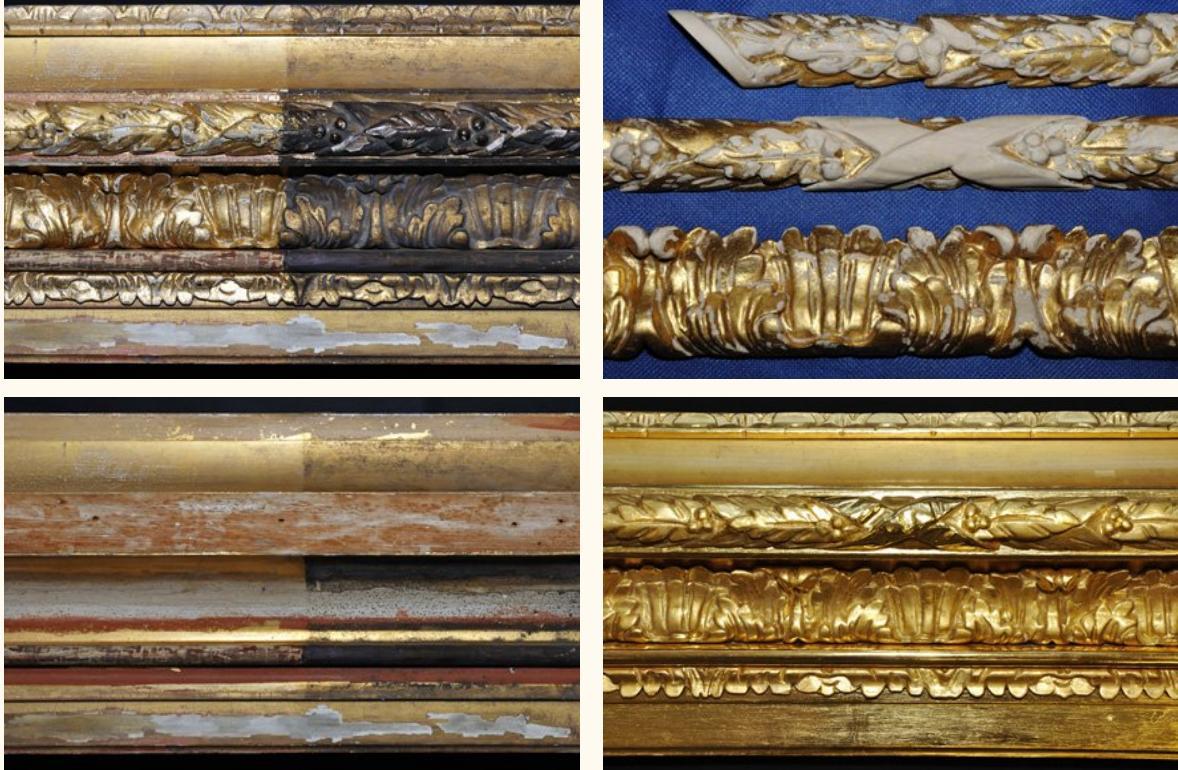
Figure 7 (above). Close-up of the left section of the frame during surface dirt and renovation glaze removal. Figure 8 (below). The same area after dismantling the decoration. The gilder applied the bole and then gold leafs selectively only on the visible areas.

The removal of the non-original protein based glaze from the water gilded surfaces was achieved using a solution of dichloromethane with ethyl formate and formic acid in ratio 1:1:0.5. In some difficult areas mechanical removal was the only option. Removal of glaze by scraping with a scalpel blade was laborious. The surface dirt from the oil gilded areas was removed with 5% triammonium citrate in distilled water.

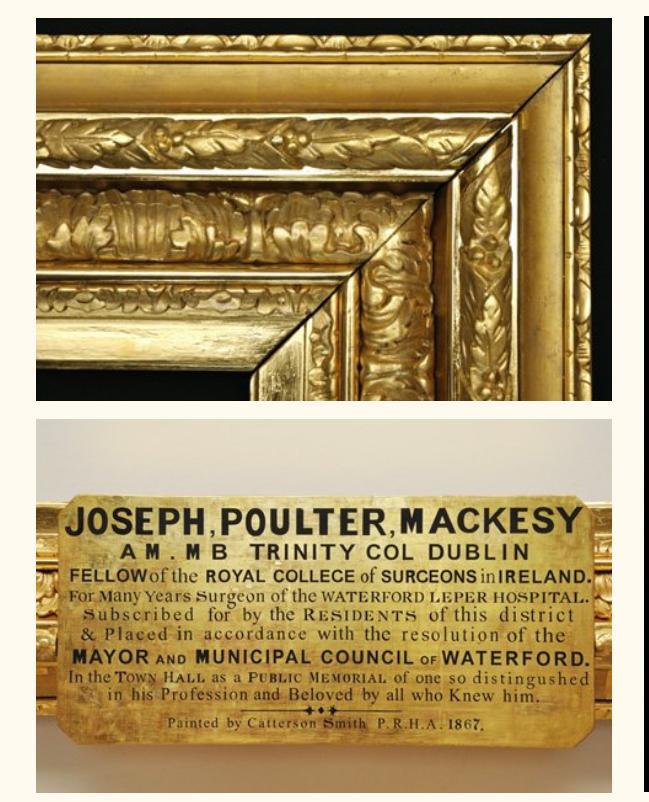
Figure 11 (above). Detail of the top-left corner of the frame after the restoration. Figure 12 (below). The original plaque with the information on the painting after the restoration.

The conservation of the plaque was technically similar to the treatments on the frame. After surface dirt removal, the flaking gesso was stabilised with 4% solution of hot rabbit skin glue. Losses of the original gesso surface were refilled with a new gesso made of chalk and rabbit glue in a 10% ratio, and then all fills were prepared by application of a new red bole in 7% rabbit glue. Next, the prepared surfaces were gilded in water gilding technique. Finally, the gilded surfaces were polished with an agate stone and toned. The lettering was reconstructed with ivory black oil paint.

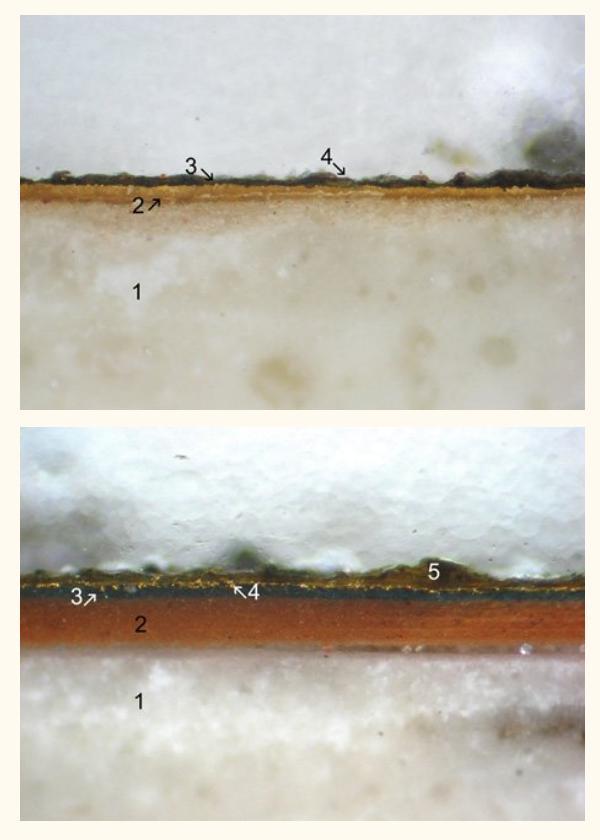
Figure 14 (above). Cross-section of gilded decoration from the frame finish photographed in reflected light (magnification 100x). This sample was taken from the torus decoration. 1-gesso; 2-yellow bole; 3-gold particles; 4-dirt layer.

Figure 15 (below). Cross-section of gilded decoration from the frame finish photographed in reflected light (magnification 100x). This sample was taken from the astragal. 1-gesso; 2-red bole; 3-blue bole; 4-gold particles; 5-dirt.
