A New Conservation Project at South Tipperary County Museum

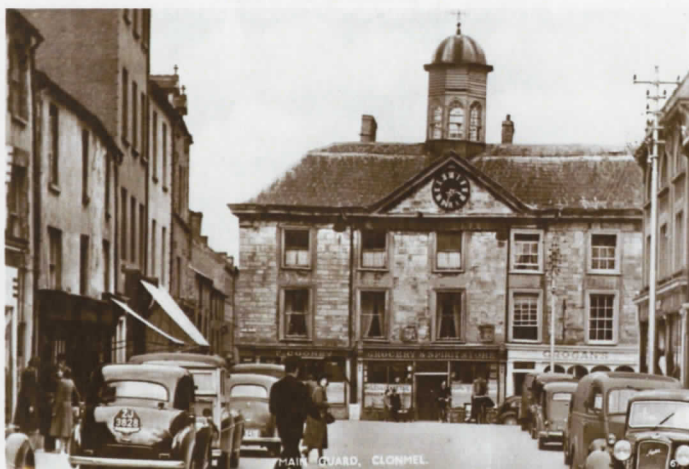
Fig 1. A postcard with a view of The Main Guard in Clonmel with Cooney's Bar shop. The postcard dates from 1951. South Tipperary County Museum collection, inv no. 1995.718.

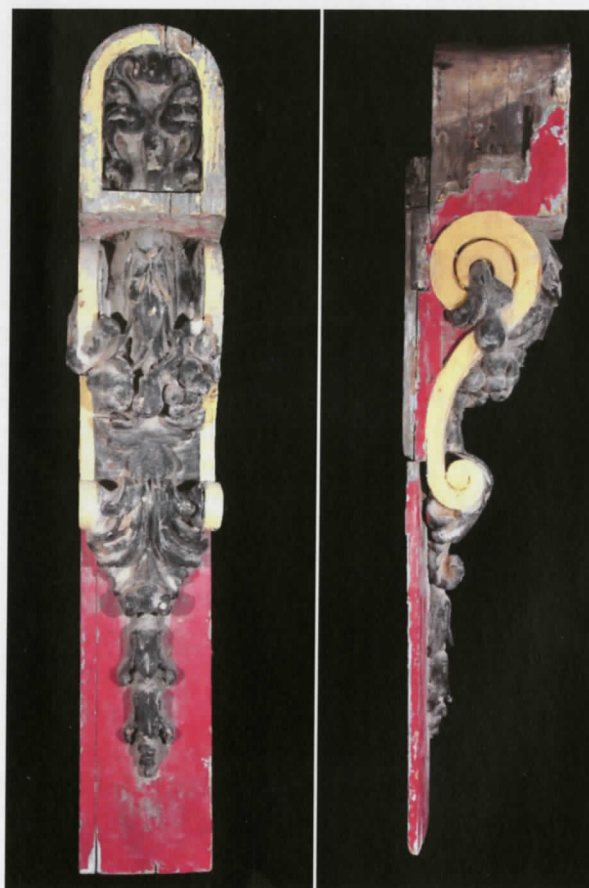
Fig 3. Front and side of main decorative console. The wooden construction has many oblong splits. The paint layer has many losses and extensively flakes unveiling previous paint schemes.

The primary aim of the conservation treatments is to halt degradation by eliminating the causes of damage and conservation of the existing material. At present, at this very preliminary stage it is clear that five core treatments will need to be carried out and these will consist of removal of dirt from the back and front of the elements pest control, consolidation and minor repairs of the wooden material reattachment of the flaking paint inpainting losses of the painting layer and conservation of the paper label from the drawer.

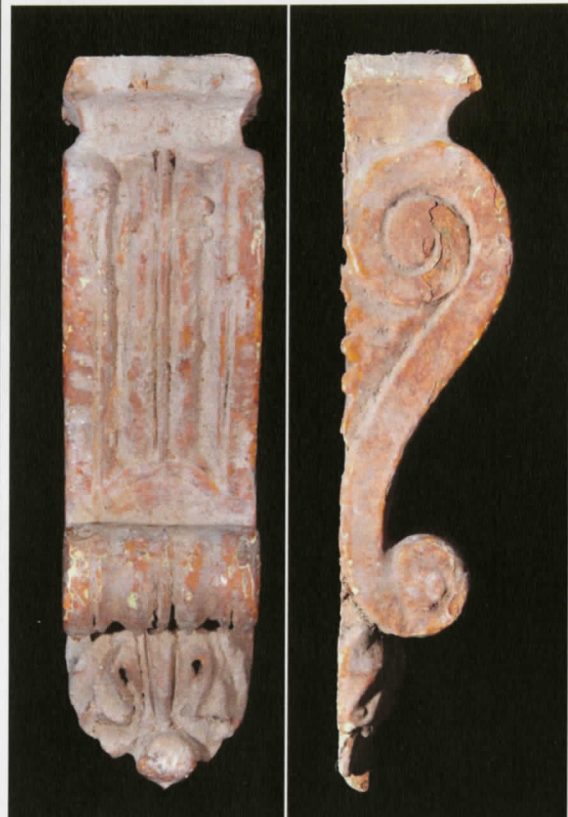
Fig. 5 One of the small consoles. The photograph shows the front and side of the console.
